# Access Compliance Report

## Public Rights-of-Way

### (Curb Ramps)

| Intersection ID: 28142 | Main Street: FLAT_CREEK_DR | Cross Street: LONGMONT_DR | Location: NE |

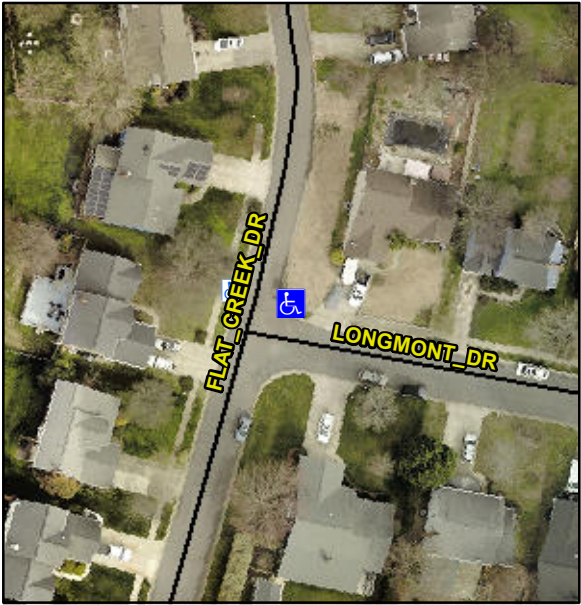
| ADA ID: 216CDD15FBE1 | Ramp Type: PerpDiag | Initial Pass/Fail: Fail | Overall Compliance: No |
| | | | Severity Score: 13.75 |

| Codes/Mitigation Info/Possible Solution | | | Field Measurements/Component Compliance | | |
|---|---|---|---|---|---|
| <p>Surveyor Notes:</p> <p><b>N/A</b></p> <p>PROW/ADA:</p> <p><b>Not Found, R304.2.2, R304.5.3</b></p> | | | N/A | Flare Type RT | N/A |

| Codes/Mitigation Info/Possible Solution | | | Field Measurements/Component Compliance | | |
|---|---|---|---|---|---|
| | <b>Remove &amp; Replace Curb Ramp With Two New Directional Ramps or Equivalent.</b> | | N/A | Ramp Length (in) | 48.0 |
| Total Cost: | | \$ 3200.00 | | | |
