Access Compliance Report

Public Rights-of-Way

(Curb Ramps)

Intersection ID: 11506	Main Street: GRACE_ST	Cross Street: UNION_ST	Location: NE
ADA ID: 2190B55266BC	Ramp Type: BlendTrans2	Initial Pass/Fail: Fail	Overall Compliance: No
		Severity Score: 10

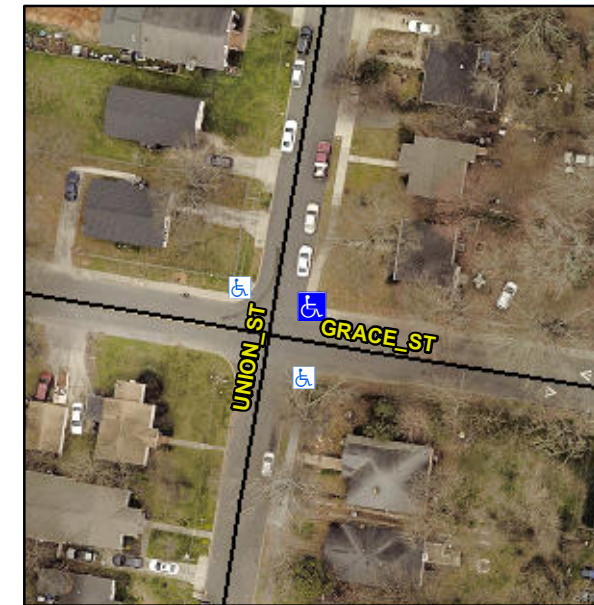
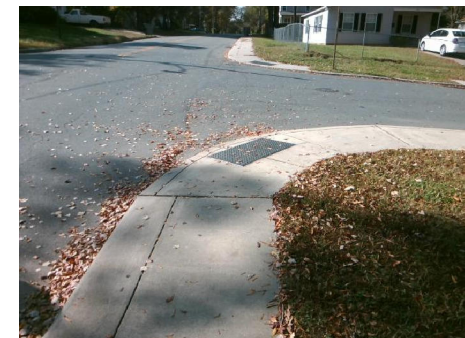
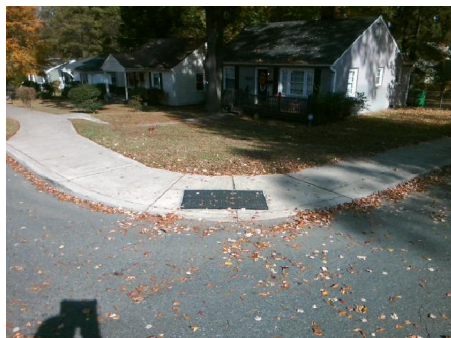
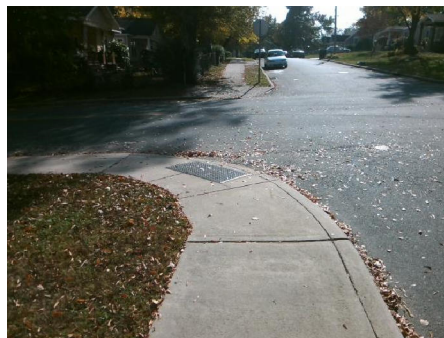
Compliance	Description	Data	Compliance	Description	Data
N/A	Ramp Length (in)	55.0	Yes	BlendTrans Slope (%)	4.4
No	Ramp Width (in)	46.0	No	BlendTrans XSlope (%)	3.8
N/A	Flare Type LT	N/A	N/A	Flare Type RT	N/A
N/A	Flare Slope LT (%)	N/A	N/A	Flare Slope RT (%)	N/A
N/A	Flare Traversable LT?	N/A	N/A	Flare Traversable RT?	N/A
N/A	Landing Length (in)	N/A	N/A	DWS Provided?	N/A
N/A	Landing Width (in)	N/A	N/A	DWS Contrast?	N/A
N/A	Landing Slope (%)	N/A	N/A	DWS Length (in)	N/A
N/A	Landing X Slope (%)	N/A	N/A	DWS Full Width?	N/A
N/A	Landing Curb? (Y/N)	N/A	N/A	DWS Offset (in)	N/A
N/A	Shared Landing?	N/A			
N/A	Gutter Ponding?	N/A	N/A	Gutter Slope (%)	N/A
N/A	Gutter Lip Ht (in)	0.5	N/A	Gutter X Slope (%)	N/A
N/A	Painted X Walk1?	No	N/A	Painted X Walk2?	No
	X Walk 1 Direction	To W		X Walk 2 Direction	To S
	X Walk 1 Width (in)	N/A		X Walk 2 Width (in)	N/A
	X Walk 1 Slope (%)	6.5		X Walk 2 Slope (%)	4.6
	X Walk 1 X Slope (%)	4.2		X Walk 2 X Slope (%)	5.8

N/A	Ramp inside XWalk1?	N/A	N/A	Ramp inside XWalk2?	N/A
	Road Slope (%)	2.6		Clear Space?	N/A
	Road X Slope (%)	5.3	N/A	Clear Space to XWalk (in)	N/A
N/A	Any Obstructions?	N/A	N/A	Storm Grate/Utility Hazard?	N/A
	Obstruction Type			Storm Grate/Utility Type	
		N/A			N/A
			Yes	Surface Condition? (G/P)	Good
			N/A	Curb Slope (%)	0.9

Possible Solutions:

Remove & Replace Curb Ramp With Two New Directional Ramps or Equivalent.

R304.5.1, R304.5.3
