Access Compliance Report

Public Rights-of-Way

(Curb Ramps)

Intersection ID: 53633	Main Street: TREMONT_RIDGE_CT	Cross Street: BEACON_VALLEY_ST	Location: SW
ADA ID: 219A28BF5842	Ramp Type: PerpDiag	Initial Pass/Fail: Fail	Overall Compliance: No
Severity Score: 33.75			
Codes/Mitigation Info/Possible Solution		Field Measurements/Component Compliance

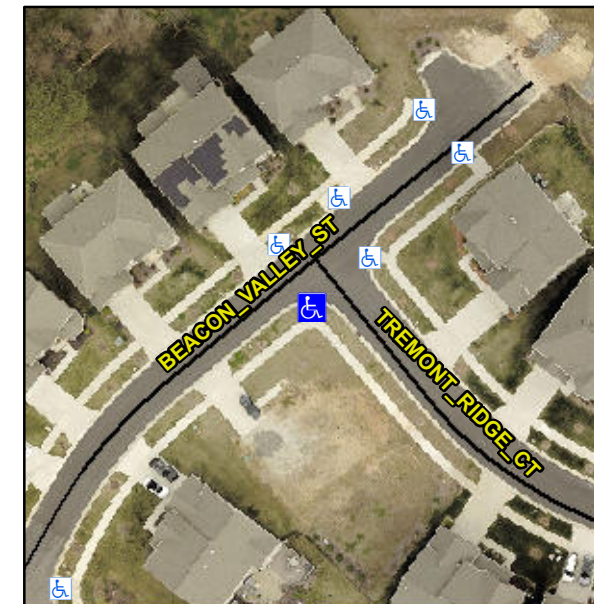
Not Found, R304.5.1, R304.5.3

Compliance	Description	Data	Compliance	Description	Data
N/A	Ramp Length (in)	95.0	Yes	Ramp Slope (%)	6.6
No	Ramp Width (in)	45.5	No	Ramp XSlope (%)	9.9
N/A	Flare Type LT	N/A	N/A	Flare Type RT	N/A
N/A	Flare Slope LT (%)	N/A	N/A	Flare Slope RT (%)	N/A
N/A	Flare Traversable LT?	N/A	N/A	Flare Traversable RT?	N/A
N/A	Landing Length (in)	N/A	N/A	DWS Provided?	N/A
N/A	Landing Width (in)	N/A	N/A	DWS Contrast?	N/A
N/A	Landing Slope (%)	N/A	N/A	DWS Length (in)	N/A
N/A	Landing X Slope (%)	N/A	N/A	DWS Full Width?	N/A
N/A	Landing Curb? (Y/N)	N/A	N/A	DWS Offset (in)	N/A
N/A	Shared Landing?	N/A			
N/A	Gutter Ponding?	N/A	N/A	Gutter Slope (%)	N/A
N/A	Gutter Lip Ht (in)	N/A	N/A	Gutter X Slope (%)	N/A
N/A	Painted X Walk1?	No	N/A	Painted X Walk2?	No
	X Walk 1 Direction	To NE		X Walk 2 Direction	To NW
N/A	X Walk 1 Width (in)	N/A	N/A	X Walk 2 Width (in)	N/A
	X Walk 1 Slope (%)	8.8		X Walk 2 Slope (%)	4.9
	X Walk 1 X Slope (%)	2.7		X Walk 2 X Slope (%)	9.0

N/A	Ramp inside XWalk1?	N/A	N/A	Ramp inside XWalk2?	N/A
	Road Slope (%)	7.8	N/A	Clear Space?	N/A
	Road X Slope (%)	4.5	N/A	Clear Space to XWalk (in)	N/A
N/A	Any Obstructions?	N/A	N/A	Storm Grate/Utility Hazard?	N/A
	Obstruction Type			Storm Grate/Utility Type	
		N/A			N/A
			Yes	Surface Condition? (G/P)	Good

Remove & Replace Curb Ramp With Two New Directional Ramps or Equivalent.
