Access Compliance Report

Public Rights-of-Way

(Curb Ramps)

| Intersection ID: N/A | Main Street: STONEHAM CT | Cross Street: CROSS POINT CIR | Location: NE |

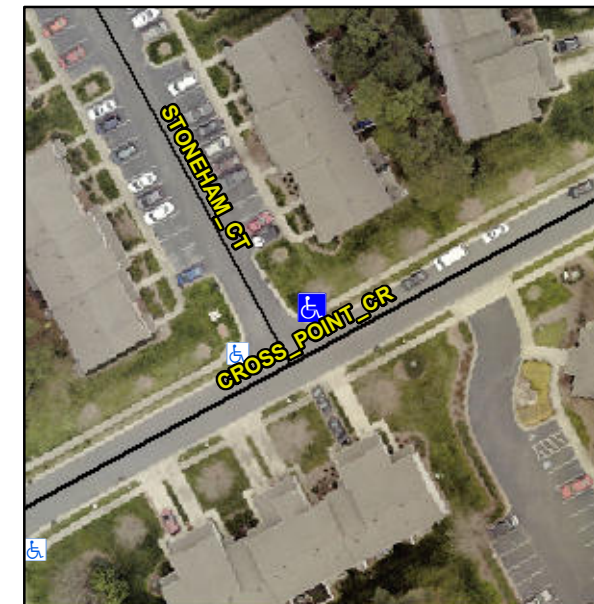
R304.5.1, R304.2.2

| Compliance | Description | Data | Compliance | Description | Data |
|---|---|---|---|---|---|
| N/A | Ramp Length (in) | 50.0 | No | Ramp Slope (%) | 10.7 |
| No | Ramp Width (in) | 37.0 | Yes | Ramp XSlope (%) | 0.0 |

Remove & Replace Curb Ramp With Two New Directional Ramps or Equivalent.
