Access Compliance Report

Public Rights-of-Way

(Curb Ramps)

| Intersection ID: 10039933 | Main Street: TRAVIS_GULCH_DR | Cross Street: N/A | Location: SW |

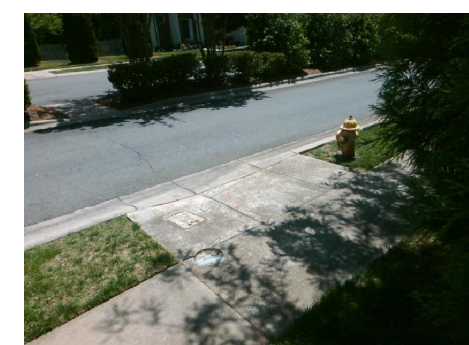
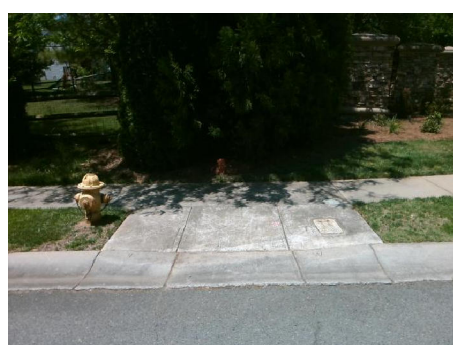
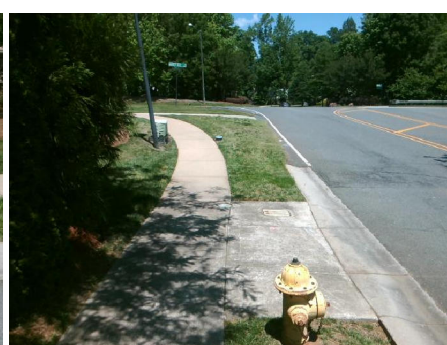
| ADA ID: 21A675E604A2 | Ramp Type: Perp | Initial Pass/Fail: Fail | Overall Compliance: No |
| Severity Score: 10 | | | |

Not Found, R304.5.1, R304.5.3

| Compliance | Description | Data | Compliance | Description | Data |
|---|---|---|---|---|---|
| N/A | Ramp Length (in) | 48.0 | Yes | Ramp Slope (%) | 5.8 |
| No | Ramp Width (in) | 47.0 | No | Ramp XSlope (%) | 3.9 |

Remove & Replace Entire Ramp.

Total Cost: \$ 1850.00
