Access Compliance Report

Public Rights-of-Way

(Curb Ramps)

Intersection ID: 14272	Main Street: BROOKHILL_RD	Cross Street: VILLAGE_CT	Location: NE
ADA ID: 21D541DEA688	Ramp Type: PerpDiag	Initial Pass/Fail: Fail	Overall Compliance: No
		Severity Score: 25

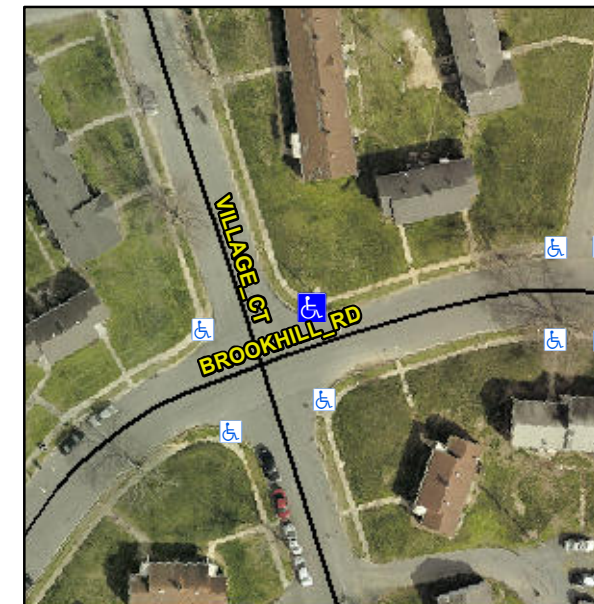
Compliance	Description	Data	Compliance	Description	Data
N/A	Ramp Length (in)	41.0	No	Ramp Slope (%)	14.4
Yes	Ramp Width (in)	48.0	Yes	Ramp XSlope (%)	1.9
N/A	Flare Type LT	N/A	N/A	Flare Type RT	N/A
N/A	Flare Slope LT (%)	N/A	N/A	Flare Slope RT (%)	N/A
N/A	Flare Traversable LT?	N/A	N/A	Flare Traversable RT?	N/A
N/A	Landing Length (in)	N/A	N/A	DWS Provided?	N/A
N/A	Landing Width (in)	N/A	N/A	DWS Contrast?	N/A
N/A	Landing Slope (%)	N/A	N/A	DWS Length (in)	N/A
N/A	Landing X Slope (%)	N/A	N/A	DWS Full Width?	N/A
N/A	Landing Curb? (Y/N)	N/A	N/A	DWS Offset (in)	N/A
N/A	Shared Landing?	N/A			
N/A	Gutter Ponding?	N/A	N/A	Gutter Slope (%)	N/A
N/A	Gutter Lip Ht (in)	N/A	N/A	Gutter X Slope (%)	N/A
N/A	Painted X Walk1?	No	N/A	Painted X Walk2?	No
	X Walk 1 Direction	To W		X Walk 2 Direction	To S
N/A	X Walk 1 Width (in)	N/A	N/A	X Walk 2 Width (in)	N/A
	X Walk 1 Slope (%)	2.5		X Walk 2 Slope (%)	4.8
	X Walk 1 X Slope (%)	4.2		X Walk 2 X Slope (%)	0.5

N/A	Ramp inside XWalk1?	N/A	N/A	Ramp inside XWalk2?	N/A
	Road Slope (%)	1.6	N/A	Clear Space?	N/A
	Road X Slope (%)	4.7	N/A	Clear Space to XWalk (in)	N/A
N/A	Any Obstructions?	N/A	N/A	Storm Grate/Utility Hazard?	N/A
	Obstruction Type			Storm Grate/Utility Type	
		N/A			N/A
			Yes	Surface Condition? (G/P)	Good

Remove & Replace Curb Ramp With Two New Directional Ramps or Equivalent.
