Access Compliance Report

Public Rights-of-Way

(Curb Ramps)

Intersection ID: N/A	Main Street: BROOKHILL_RD	Cross Street: N/A	Location: NW
ADA ID: 21FDF308758A	Ramp Type: PerpDiag	Initial Pass/Fail: Fail	Overall Compliance: No
Codes/Mitigation Info/Possible Solution		Field Measurements/Component Compliance	
Severity Score: 28.75

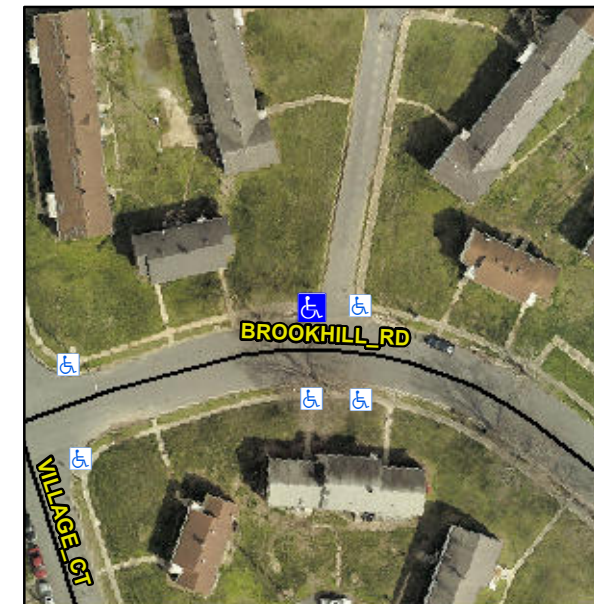
Compliance	Description	Data	Compliance	Description	Data
N/A	Ramp Length (in)	35.0	No	Ramp Slope (%)	10.3
Yes	Ramp Width (in)	48.0	Yes	Ramp XSlope (%)	2.4
N/A	Flare Type LT	N/A	N/A	Flare Type RT	N/A
N/A	Flare Slope LT (%)	N/A	N/A	Flare Slope RT (%)	N/A
N/A	Flare Traversable LT?	N/A	N/A	Flare Traversable RT?	N/A
N/A	Landing Length (in)	N/A	N/A	DWS Provided?	N/A
N/A	Landing Width (in)	N/A	N/A	DWS Contrast?	N/A
N/A	Landing Slope (%)	N/A	N/A	DWS Length (in)	N/A
N/A	Landing X Slope (%)	N/A	N/A	DWS Full Width?	N/A
N/A	Landing Curb? (Y/N)	N/A	N/A	DWS Offset (in)	N/A
N/A	Shared Landing?	N/A			
N/A	Gutter Ponding?	N/A	N/A	Gutter Slope (%)	N/A
N/A	Gutter Lip Ht (in)	5.5	N/A	Gutter X Slope (%)	N/A
N/A	Painted X Walk1?	No	N/A	Painted X Walk2?	No
	X Walk 1 Direction	To S		X Walk 2 Direction	To E
N/A	X Walk 1 Width (in)	N/A	N/A	X Walk 2 Width (in)	N/A
	X Walk 1 Slope (%)	0.3		X Walk 2 Slope (%)	6.8
	X Walk 1 X Slope (%)	8.0		X Walk 2 X Slope (%)	7.0

N/A	Ramp inside XWalk1?	N/A	N/A	Ramp inside XWalk2?	N/A
	Road Slope (%)	15.2	N/A	Clear Space?	N/A
	Road X Slope (%)	2.3	N/A	Clear Space to XWalk (in)	N/A
N/A	Any Obstructions?	N/A	N/A	Storm Grate/Utility Hazard?	N/A
	Obstruction Type			Storm Grate/Utility Type	
		N/A			N/A
		No		Surface Condition? (G/P)	Poor

Remove & Replace Curb Ramp With Two New Directional Ramps or Equivalent.

R304.2.2, R302.7
