Access Compliance Report

Public Rights-of-Way

(Curb Ramps)

Intersection ID: 48949	Main Street: OLD_STONE_CROSSING_DR	Cross Street: DAVID_JENNINGS_AV	Location: E
ADA ID: 21FEBCEBDE1	Ramp Type: PerpDiag	Initial Pass/Fail: Fail	Overall Compliance: No
Severity Score: 8.75			
Codes/Mitigation Info/Possible Solution		Field Measurements/Component Compliance

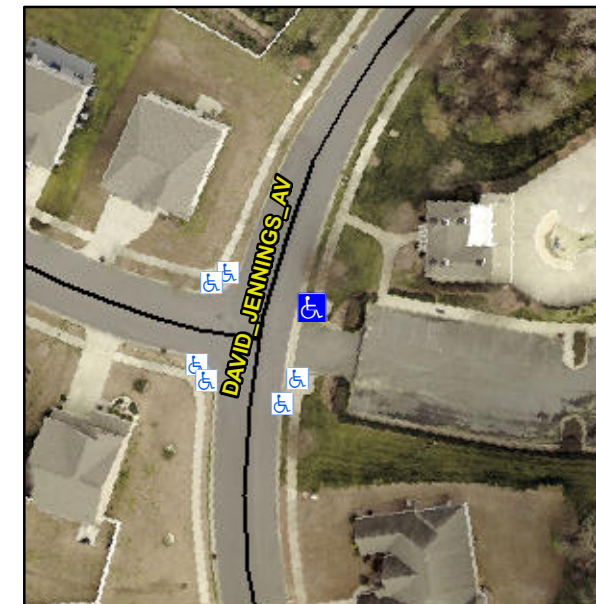
Compliance	Description	Data	Compliance	Description	Data
N/A	Ramp Length (in)	47.5	Yes	Ramp Slope (%)	6.1
No	Ramp Width (in)	47.5	Yes	Ramp XSlope (%)	1.2
N/A	Flare Type LT	N/A	N/A	Flare Type RT	N/A
N/A	Flare Slope LT (%)	N/A	N/A	Flare Slope RT (%)	N/A
N/A	Flare Traversable LT?	N/A	N/A	Flare Traversable RT?	N/A
N/A	Landing Length (in)	N/A	N/A	DWS Provided?	N/A
N/A	Landing Width (in)	N/A	N/A	DWS Contrast?	N/A
N/A	Landing Slope (%)	N/A	N/A	DWS Length (in)	N/A
N/A	Landing X Slope (%)	N/A	N/A	DWS Full Width?	N/A
N/A	Landing Curb? (Y/N)	N/A	N/A	DWS Offset (in)	N/A
N/A	Shared Landing?	N/A			
N/A	Gutter Ponding?	N/A	N/A	Gutter Slope (%)	N/A
N/A	Gutter Lip Ht (in)	1.0	N/A	Gutter X Slope (%)	N/A
N/A	Painted X Walk1?	No	N/A	Painted X Walk2?	No
	X Walk 1 Direction	To NW		X Walk 2 Direction	To S
N/A	X Walk 1 Width (in)	N/A	N/A	X Walk 2 Width (in)	N/A
	X Walk 1 Slope (%)	1.4		X Walk 2 Slope (%)	1.4
	X Walk 1 X Slope (%)	3.3		X Walk 2 X Slope (%)	3.6

N/A	Ramp inside XWalk1?	N/A	N/A	Ramp inside XWalk2?	N/A
	Road Slope (%)	0.7	N/A	Clear Space?	N/A
	Road X Slope (%)	5.6	N/A	Clear Space to XWalk (in)	N/A
N/A	Any Obstructions?	N/A	N/A	Storm Grate/Utility Hazard?	N/A
	Obstruction Type			Storm Grate/Utility Type	
		N/A			N/A
			Yes	Surface Condition? (G/P)	Good

Possible Solutions:

Remove & Replace Curb Ramp With Two New Directional Ramps or Equivalent.

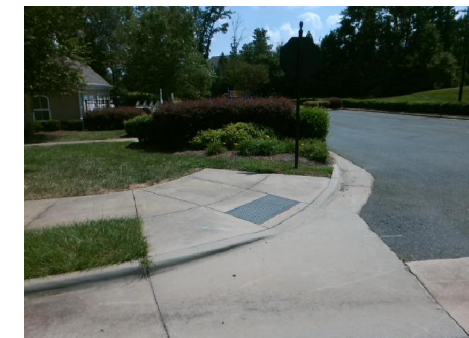
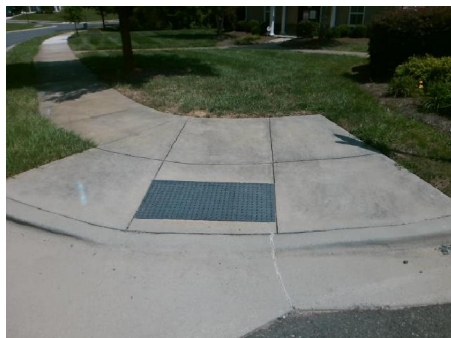
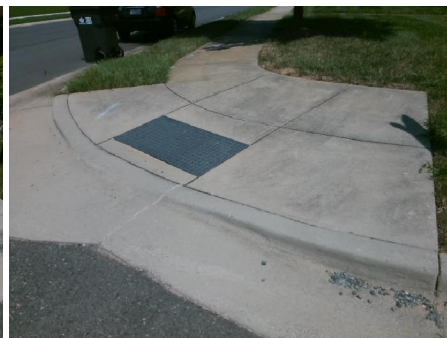
Street 1 Name DAVID JENNINGS AV
 Stop Condition-Street 2 None
 Street 2 Name OLD STONE CROSSING DR
 Stop Condition-Street 1 StopSign
