Access Compliance Report

Public Rights-of-Way

(Curb Ramps)

Intersection ID: 27286	Main Street: ELMSTONE_DR	Cross Street: THORNHILL_CLUB_DR	Location: SW
ADA ID: 22074BC418AC	Ramp Type: PerpDiag	Initial Pass/Fail: Fail	Overall Compliance: No
			Severity Score: 21.25

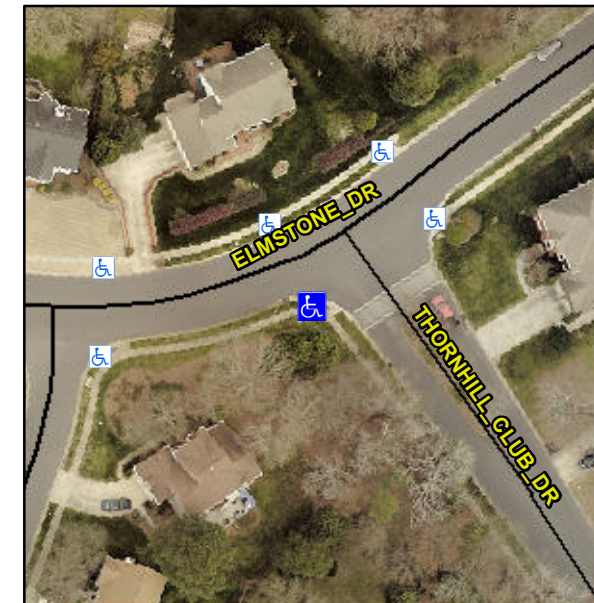
Not Found, R304.5.1, R304.5.3

Compliance	Description	Data	Compliance	Description	Data
N/A	Ramp Length (in)	92.0	Yes	Ramp Slope (%)	6.2
No	Ramp Width (in)	45.5	No	Ramp XSlope (%)	5.2
N/A	Flare Type LT	N/A	N/A	Flare Type RT	N/A
N/A	Flare Slope LT (%)	N/A	N/A	Flare Slope RT (%)	N/A
N/A	Flare Traversable LT?	N/A	N/A	Flare Traversable RT?	N/A
N/A	Landing Length (in)	N/A	N/A	DWS Provided?	N/A
N/A	Landing Width (in)	N/A	N/A	DWS Contrast?	N/A
N/A	Landing Slope (%)	N/A	N/A	DWS Length (in)	N/A
N/A	Landing X Slope (%)	N/A	N/A	DWS Full Width?	N/A
N/A	Landing Curb? (Y/N)	N/A	N/A	DWS Offset (in)	N/A
N/A	Shared Landing?	N/A			
N/A	Gutter Ponding?	N/A	N/A	Gutter Slope (%)	N/A
N/A	Gutter Lip Ht (in)	N/A	N/A	Gutter X Slope (%)	N/A
N/A	Painted X Walk1?	No	N/A	Painted X Walk2?	No
	X Walk 1 Direction	To NE		X Walk 2 Direction	To N
N/A	X Walk 1 Width (in)	N/A	N/A	X Walk 2 Width (in)	N/A
	X Walk 1 Slope (%)	5.5		X Walk 2 Slope (%)	7.6
	X Walk 1 X Slope (%)	8.0		X Walk 2 X Slope (%)	0.7

N/A	Ramp inside XWalk1?	N/A	N/A	Ramp inside XWalk2?	N/A
	Road Slope (%)	7.5	N/A	Clear Space?	N/A
	Road X Slope (%)	0.5	N/A	Clear Space to XWalk (in)	N/A
N/A	Any Obstructions?	N/A	N/A	Storm Grate/Utility Hazard?	N/A
	Obstruction Type			Storm Grate/Utility Type	
		N/A			N/A
			Yes	Surface Condition? (G/P)	Good

Remove & Replace Curb Ramp With Two New Directional Ramps or Equivalent.

Total Cost: \$ 3200.00
