Access Compliance Report

Public Rights-of-Way

(Curb Ramps)

Intersection ID: 14918	Main Street: KENILWORTH_AV	Cross Street: PIERCE_ST	Location: W
ADA ID: 2218055557BB	Ramp Type: Directional	Initial Pass/Fail: Fail	Overall Compliance: No
Severity Score: 12.5			
Codes/Mitigation Info/Possible Solution		Field Measurements/Component Compliance

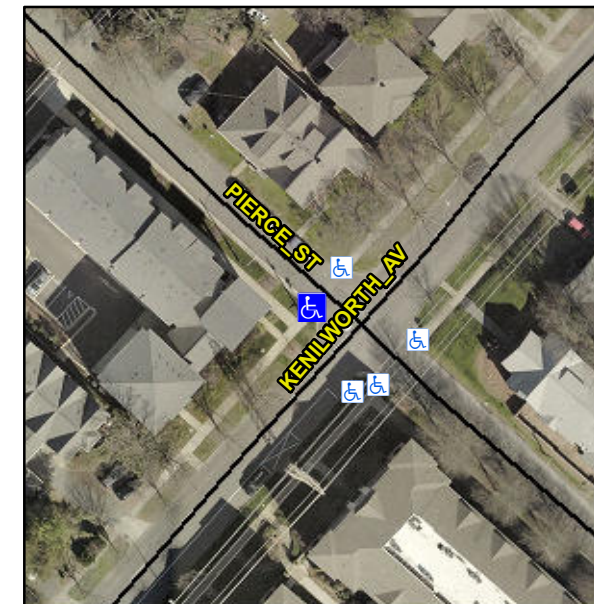
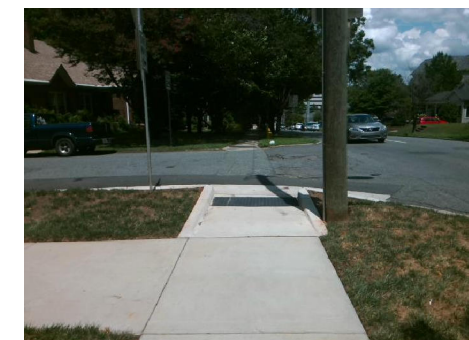
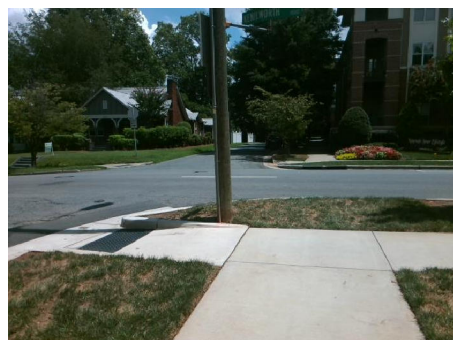
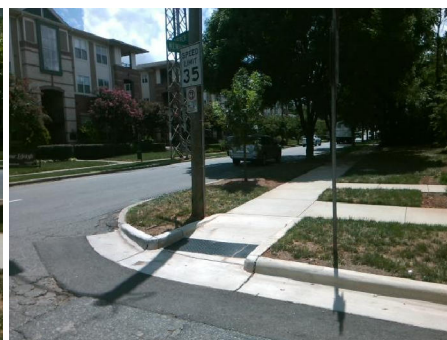
Compliance	Description	Data	Compliance	Description	Data
N/A	Ramp Length (in)	86.0	N/A	Grade Break?	N/A
Yes	Ramp Width (in)	58.0	N/A	Grade Break Slope (%)	0.0
No	Ramp Slope (%)	11.5	N/A	Grade Break XSlope (%)	0.0
Yes	Ramp XSlope (%)	1.8			
N/A	Flare Type LT	N/A	N/A	Flare Type RT	N/A
N/A	Flare Slope LT (%)	N/A	N/A	Flare Slope RT (%)	0.0
N/A	Flare Traversable LT?	N/A	N/A	Flare Traversable RT?	N/A
N/A	Landing Length (in)	0.0	N/A	DWS Provided?	N/A
N/A	Landing Width (in)	0.0	N/A	DWS Contrast?	N/A
N/A	Landing Slope (%)	0.0	N/A	DWS Length (in)	N/A
N/A	Landing X Slope (%)	0.0	N/A	DWS Full Width?	N/A
N/A	Landing Curb? (Y/N)	N/A	N/A	DWS Offset LT (in)	N/A
N/A	Shared Landing?	N/A	N/A	DWS Offset RT (in)	N/A
N/A	Gutter Ponding?	0.0	N/A	Gutter Slope (%)	N/A
N/A	Gutter Lip Ht (in)	0.0	N/A	Gutter X Slope (%)	N/A
N/A	Painted X Walk1?	No		Road Slope (%)	1.5
	X Walk 1 Direction	To NE		Road X Slope (%)	1.7
	X Walk 1 Width (in)	N/A		Clear Space?	N/A

X Walk 1 Slope (%)	1.5	N/A	Clear Space to XWalk (in)	N/A
	X Walk 1 X Slope (%)	1.7	N/A	Storm Grate/Utility Hazard?	N/A
N/A	Ramp inside XWalk1?	N/A		Storm Grate/Utility Type	
N/A	Any Obstructions?	N/A			
	Obstruction Type		Yes	Surface Condition? (G/P)	Good
			N/A	Curb Slope (%)	3.4

Possible Solutions:

Remove & Replace Entire Ramp.

R304.2.2
