# Access Compliance Report

## Public Rights-of-Way

### (Curb Ramps)

Intersection ID: 15179	Main Street: DRESDEN_DR_EAST	Cross Street: WESTCHESTER_BV	Location: NW
ADA ID: 2229BA547E7B	Ramp Type: PerpDiag	Initial Pass/Fail: Fail	Overall Compliance: No
			Severity Score: 21.25

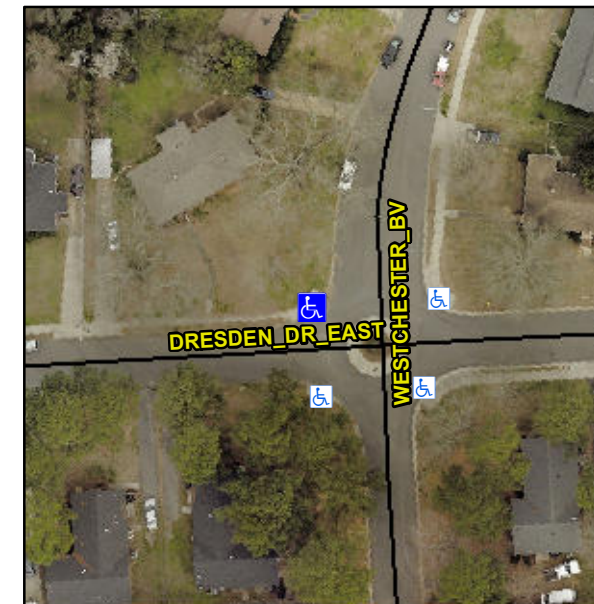
**Not Found, R304.5.1, R304.2.2**

Compliance	Description	Data	Compliance	Description	Data
N/A	Ramp Length (in)	72.0	No	Ramp Slope (%)	9.2
No	Ramp Width (in)	42.0	Yes	Ramp XSlope (%)	0.8
N/A	Flare Type LT	N/A	N/A	Flare Type RT	N/A
N/A	Flare Slope LT (%)	N/A	N/A	Flare Slope RT (%)	N/A
N/A	Flare Traversable LT?	N/A	N/A	Flare Traversable RT?	N/A
N/A	Landing Length (in)	N/A	N/A	DWS Provided?	N/A
N/A	Landing Width (in)	N/A	N/A	DWS Contrast?	N/A
N/A	Landing Slope (%)	N/A	N/A	DWS Length (in)	N/A
N/A	Landing X Slope (%)	N/A	N/A	DWS Full Width?	N/A
N/A	Landing Curb? (Y/N)	N/A	N/A	DWS Offset (in)	N/A
N/A	Shared Landing?	N/A			
N/A	Gutter Ponding?	N/A	N/A	Gutter Slope (%)	N/A
N/A	Gutter Lip Ht (in)	N/A	N/A	Gutter X Slope (%)	N/A
N/A	Painted X Walk1?	No	N/A	Painted X Walk2?	No
	X Walk 1 Direction	To S		X Walk 2 Direction	To E
N/A	X Walk 1 Width (in)	N/A	N/A	X Walk 2 Width (in)	N/A
	X Walk 1 Slope (%)	0.1		X Walk 2 Slope (%)	3.2
	X Walk 1 X Slope (%)	1.3		X Walk 2 X Slope (%)	1.5

N/A	Ramp inside XWalk1?	N/A	N/A	Ramp inside XWalk2?	N/A
	Road Slope (%)	1.6	N/A	Clear Space?	N/A
	Road X Slope (%)	1.5	N/A	Clear Space to XWalk (in)	N/A
N/A	Any Obstructions?	N/A	N/A	Storm Grate/Utility Hazard?	N/A
	Obstruction Type			Storm Grate/Utility Type	
		N/A			N/A
			Yes	Surface Condition? (G/P)	Good

**Remove & Replace Curb Ramp With Two New Directional Ramps or Equivalent.**
