Access Compliance Report

Public Rights-of-Way

(Curb Ramps)

| Intersection ID: 44333 | Main Street: BROWNE_RD | Cross Street: RETRIEVER_WY | Location: NE |

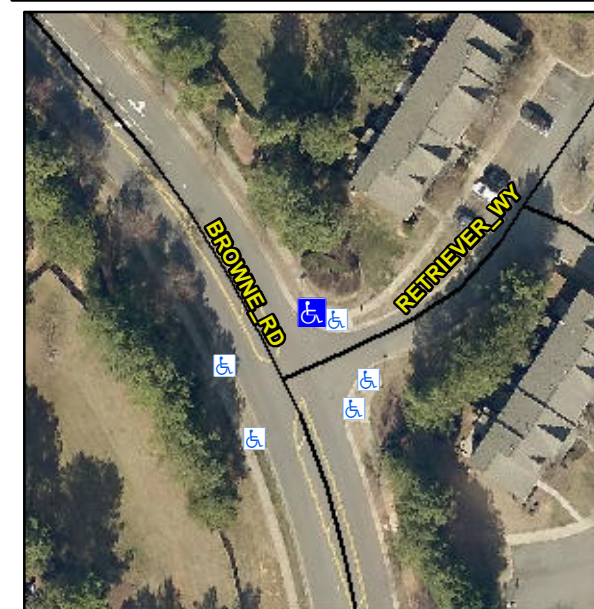
| ADA ID: 2236388B545E | Ramp Type: Perp | Initial Pass/Fail: Fail | Overall Compliance: No |
| Severity Score: 12.5 | | | |

R304.2.2

| Compliance | Description | Data | Compliance | Description | Data |
|---|---|---|---|---|---|
| N/A | Ramp Length (in) | 65.0 | No | Ramp Slope (%) | 11.7 |
| Yes | Ramp Width (in) | 48.0 | Yes | Ramp XSlope (%) | 1.7 |

Possible Solutions:

Remove & Replace Entire Ramp.

Total Cost:

\$ 1850.00
