Access Compliance Report

Public Rights-of-Way

(Curb Ramps)

Intersection ID: 53635	Main Street: NEWBURY GROVE ST	Cross Street: TREMONT RIDGE CT	Location: NW
ADA ID: 223864BC6D2B	Ramp Type: Perp	Initial Pass/Fail: Fail	Overall Compliance: No
Codes/Mitigation Info/Possible Solution		Field Measurements/Component Compliance	
Severity Score: 1.25

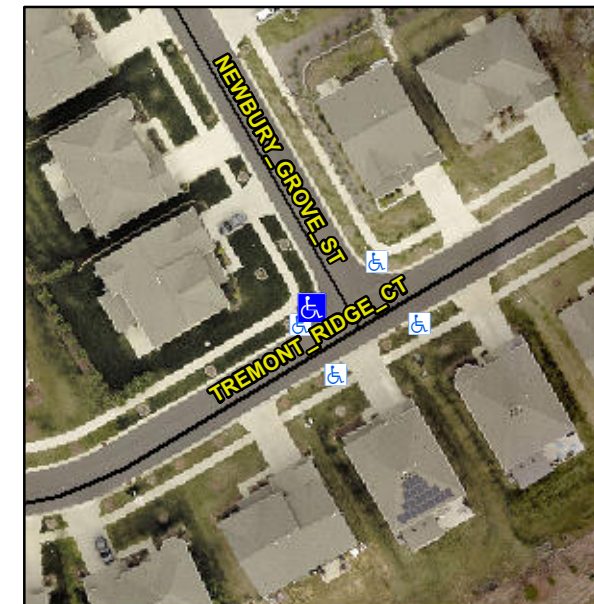
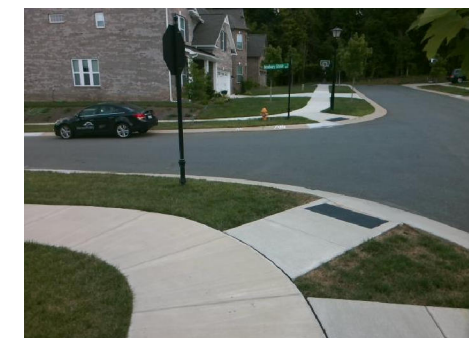
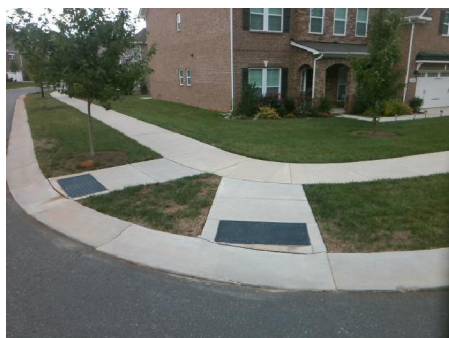
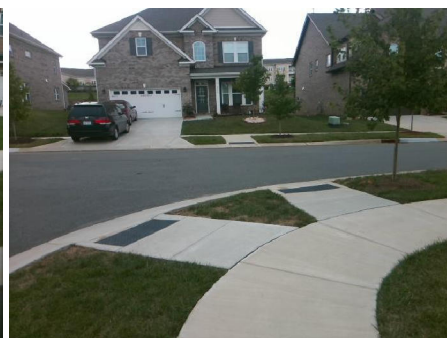
Compliance	Description	Data	Compliance	Description	Data
N/A	Ramp Length (in)	101.0	Yes	Ramp Slope (%)	7.4
Yes	Ramp Width (in)	60.0	No	Ramp XSlope (%)	2.8
N/A	Flare Type LT	N/A	N/A	Flare Type RT	N/A
N/A	Flare Slope LT (%)	N/A	N/A	Flare Slope RT (%)	N/A
N/A	Flare Traversable LT?	N/A	N/A	Flare Traversable RT?	N/A
N/A	Landing Length (in)	N/A	N/A	DWS Provided?	N/A
N/A	Landing Width (in)	N/A	N/A	DWS Contrast?	N/A
N/A	Landing Slope (%)	N/A	N/A	DWS Length (in)	N/A
N/A	Landing X Slope (%)	N/A	N/A	DWS Full Width?	N/A
N/A	Landing Curb? (Y/N)	N/A	N/A	DWS Offset (in)	N/A
N/A	Shared Landing?	N/A			
N/A	Gutter Ponding?	N/A	N/A	Gutter Slope (%)	N/A
N/A	Gutter Lip Ht (in)	N/A	N/A	Gutter X Slope (%)	N/A
N/A	Painted X Walk1?	No	N/A	Painted X Walk2?	N/A
	X Walk 1 Direction	To NE		X Walk 2 Direction	N/A
N/A	X Walk 1 Width (in)	N/A	N/A	X Walk 2 Width (in)	N/A
	X Walk 1 Slope (%)	8.3		X Walk 2 Slope (%)	N/A
	X Walk 1 X Slope (%)	8.4		X Walk 2 X Slope (%)	N/A

N/A	Ramp inside XWalk1?	N/A	N/A	Ramp inside XWalk2?	N/A
	Road Slope (%)	N/A	N/A	Clear Space?	N/A
	Road X Slope (%)	N/A	N/A	Clear Space to XWalk (in)	N/A
N/A	Any Obstructions?	N/A	N/A	Storm Grate/Utility Hazard?	N/A
	Obstruction Type			Storm Grate/Utility Type	
		N/A			N/A
			Yes	Surface Condition? (G/P)	Good

Possible Solutions:

Remove & Replace Entire Ramp.

PROW/ADA:

R304.5.3
