# Access Compliance Report

## Public Rights-of-Way

### (Curb Ramps)

Intersection ID: 10243	Main Street: KARENDALE_AV	Cross Street: TUCKASEEGEE_RD	Location: NE
ADA ID: 223B1E776B35	Ramp Type: Perp	Initial Pass/Fail: Fail	Overall Compliance: No
		Severity Score: 1.25

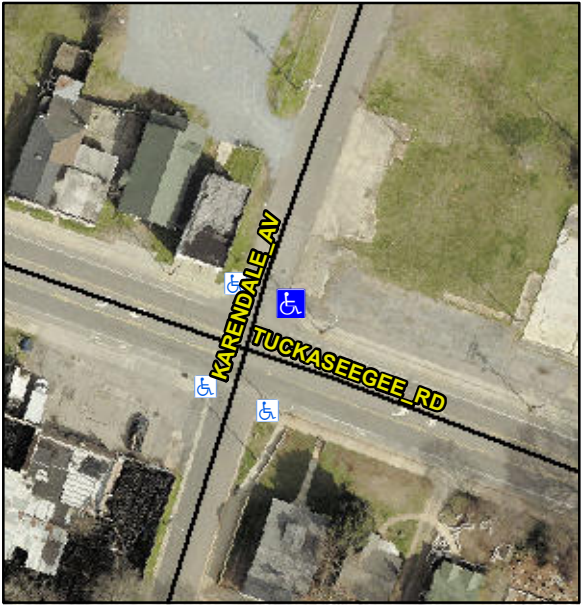
Possible Solutions:		<b>Compliance</b>	<b>Description</b>	<b>Data</b>
	<b>Remove &amp; Replace Entire Ramp.</b>		<b>Yes</b>	Ramp Length (in)	72.0
			<b>No</b>	Ramp Width (in)	48.0
			<b>N/A</b>	Flare Type LT	N/A
			<b>N/A</b>	Flare Slope LT (%)	N/A
			<b>N/A</b>	Flare Traversable LT?	N/A
			<b>N/A</b>	Landing Length (in)	N/A
			<b>N/A</b>	Landing Width (in)	N/A
			<b>N/A</b>	Landing Slope (%)	N/A
			<b>N/A</b>	Landing X Slope (%)	N/A
<p>Surveyor Notes:</p> <p><b>N/A</b></p> <p>PROW/ADA:</p> <p><b>Not Found, R304.5.3</b></p>			<b>N/A</b>	Flare Type RT	N/A
			<b>N/A</b>	Flare Slope RT (%)	N/A
			<b>N/A</b>	Flare Traversable RT?	N/A
			<b>N/A</b>	DWS Provided?	N/A
			<b>N/A</b>	DWS Contrast?	N/A
			<b>N/A</b>	DWS Length (in)	N/A
			<b>N/A</b>	DWS Full Width?	N/A
			<b>N/A</b>	DWS Offset (in)	N/A
			<b>N/A</b>	Gutter Ponding?	N/A

<b>N/A</b>	Gutter Lip Ht (in)	N/A
			<b>No</b>	Painted X Walk1?	N/A
			<b>To W</b>	X Walk 1 Direction	N/A
			<b>N/A</b>	X Walk 1 Width (in)	N/A
			<b>5.0</b>	X Walk 1 Slope (%)	N/A
			<b>8.4</b>	X Walk 1 X Slope (%)	N/A
			<b>N/A</b>	Ramp inside XWalk1?	N/A
			<b>N/A</b>	Road Slope (%)	N/A
			<b>N/A</b>	Road X Slope (%)	N/A
			<b>N/A</b>	Any Obstructions?	N/A
				Obstruction Type	N/A
Total Cost:		\$ 1850.00	<b>N/A</b>	Clear Space?	N/A
			<b>N/A</b>	Clear Space to XWalk (in)	N/A
			<b>N/A</b>	Storm Grate/Utility Hazard?	N/A
				Storm Grate/Utility Type	N/A
			<b>Yes</b>	Surface Condition? (G/P)	Good
