Access Compliance Report

Public Rights-of-Way

(Curb Ramps)

Intersection ID: 44463	Main Street: BUCKHORN_ST	Cross Street: VALCOURT_RD	Location: SW
ADA ID: 223C04D1679E	Ramp Type: PerpDiag	Initial Pass/Fail: Fail	Overall Compliance: No
Severity Score: 10			
Codes/Mitigation Info/Possible Solution		Field Measurements/Component Compliance

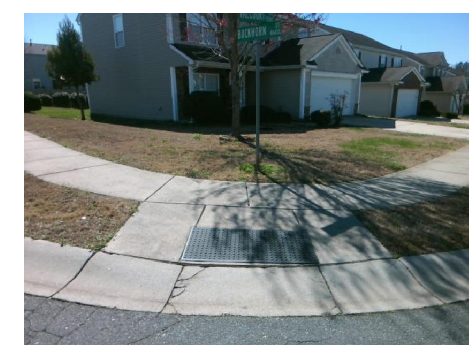
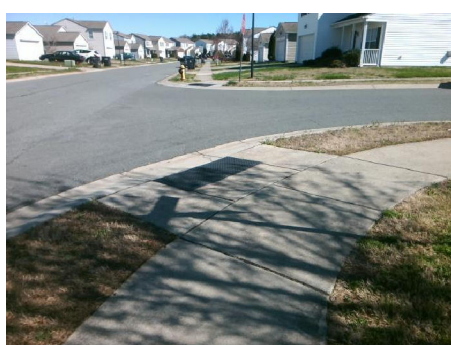
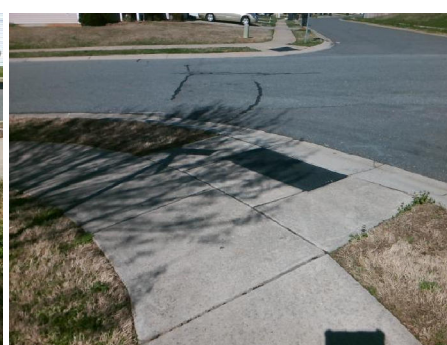
Not Found, R304.5.1, R304.5.3

Compliance	Description	Data	Compliance	Description	Data
N/A	Ramp Length (in)	51.0	Yes	Ramp Slope (%)	7.1
No	Ramp Width (in)	41.5	No	Ramp XSlope (%)	3.7
N/A	Flare Type LT	N/A	N/A	Flare Type RT	N/A
N/A	Flare Slope LT (%)	N/A	N/A	Flare Slope RT (%)	N/A
N/A	Flare Traversable LT?	N/A	N/A	Flare Traversable RT?	N/A
N/A	Landing Length (in)	N/A	N/A	DWS Provided?	N/A
N/A	Landing Width (in)	N/A	N/A	DWS Contrast?	N/A
N/A	Landing Slope (%)	N/A	N/A	DWS Length (in)	N/A
N/A	Landing X Slope (%)	N/A	N/A	DWS Full Width?	N/A
N/A	Landing Curb? (Y/N)	N/A	N/A	DWS Offset (in)	N/A
N/A	Shared Landing?	N/A			
N/A	Gutter Ponding?	N/A	N/A	Gutter Slope (%)	N/A
N/A	Gutter Lip Ht (in)	N/A	N/A	Gutter X Slope (%)	N/A
N/A	Painted X Walk1?	No	N/A	Painted X Walk2?	No
	X Walk 1 Direction	To E		X Walk 2 Direction	To N
N/A	X Walk 1 Width (in)	N/A	N/A	X Walk 2 Width (in)	N/A
	X Walk 1 Slope (%)	2.2		X Walk 2 Slope (%)	0.0
	X Walk 1 X Slope (%)	2.4		X Walk 2 X Slope (%)	2.6

N/A	Ramp inside XWalk1?	N/A	N/A	Ramp inside XWalk2?	N/A
	Road Slope (%)	2.2	N/A	Clear Space?	N/A
	Road X Slope (%)	0.5	N/A	Clear Space to XWalk (in)	N/A
N/A	Any Obstructions?	N/A	N/A	Storm Grate/Utility Hazard?	N/A
	Obstruction Type			Storm Grate/Utility Type	
		N/A			N/A
			Yes	Surface Condition? (G/P)	Good

Remove & Replace Curb Ramp With Two New Directional Ramps or Equivalent.
