# Access Compliance Report

## Public Rights-of-Way

### (Curb Ramps)

Intersection ID: 53745	Main Street: SPRINGWOOD_ESTATE_DR	Cross Street: CANTERBURY_CASTLE_DR	Location: SE
ADA ID: 224EEB958556	Ramp Type: Perp	Initial Pass/Fail: Fail	Overall Compliance: No
Severity Score: 12.5			
Codes/Mitigation Info/Possible Solution		Field Measurements/Component Compliance

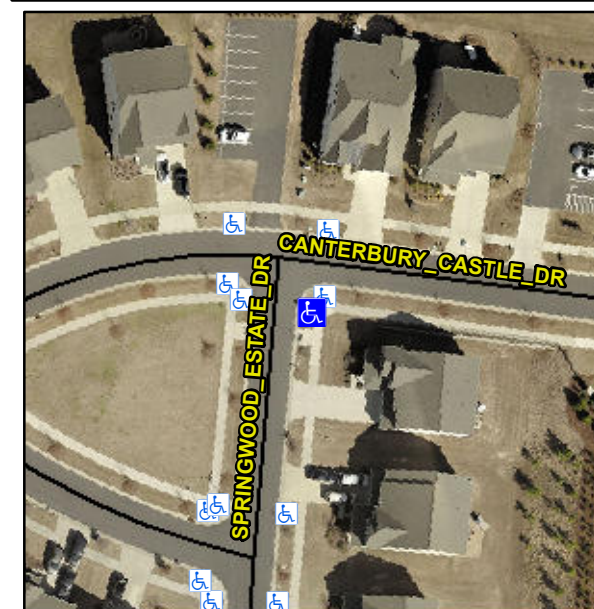
**Not Found, R304.2.2**

Compliance	Description	Data	Compliance	Description	Data
N/A	Ramp Length (in)	94.0	No	Ramp Slope (%)	8.8
Yes	Ramp Width (in)	48.0	Yes	Ramp XSlope (%)	2.0
N/A	Flare Type LT	N/A	N/A	Flare Type RT	N/A
N/A	Flare Slope LT (%)	N/A	N/A	Flare Slope RT (%)	N/A
N/A	Flare Traversable LT?	N/A	N/A	Flare Traversable RT?	N/A
N/A	Landing Length (in)	N/A	N/A	DWS Provided?	N/A
N/A	Landing Width (in)	N/A	N/A	DWS Contrast?	N/A
N/A	Landing Slope (%)	N/A	N/A	DWS Length (in)	N/A
N/A	Landing X Slope (%)	N/A	N/A	DWS Full Width?	N/A
N/A	Landing Curb? (Y/N)	N/A	N/A	DWS Offset (in)	N/A
N/A	Shared Landing?	N/A			
N/A	Gutter Ponding?	N/A	N/A	Gutter Slope (%)	N/A
N/A	Gutter Lip Ht (in)	N/A	N/A	Gutter X Slope (%)	N/A
N/A	Painted X Walk1?	No	N/A	Painted X Walk2?	N/A
	X Walk 1 Direction	To NW		X Walk 2 Direction	N/A
N/A	X Walk 1 Width (in)	N/A	N/A	X Walk 2 Width (in)	N/A
	X Walk 1 Slope (%)	1.9		X Walk 2 Slope (%)	N/A
	X Walk 1 X Slope (%)	1.4		X Walk 2 X Slope (%)	N/A

N/A	Ramp inside XWalk1?	N/A	N/A	Ramp inside XWalk2?	N/A
	Road Slope (%)	N/A	N/A	Clear Space?	N/A
	Road X Slope (%)	N/A	N/A	Clear Space to XWalk (in)	N/A
N/A	Any Obstructions?	N/A	N/A	Storm Grate/Utility Hazard?	N/A
	Obstruction Type			Storm Grate/Utility Type	
		N/A			N/A
			Yes	Surface Condition? (G/P)	Good

Possible Solutions:

**Remove & Replace Entire Ramp.**

Total Cost: \$ 1850.00
