Access Compliance Report

Public Rights-of-Way

(Curb Ramps)

Intersection ID: 8512	Main Street: ISENHOUR_ST	Cross Street: MCARTHUR_AV	Location: NE
ADA ID: 22561F9C123F	Ramp Type: Perp	Initial Pass/Fail: Fail	Overall Compliance: No
Severity Score: 55			
Codes/Mitigation Info/Possible Solution		Field Measurements/Component Compliance

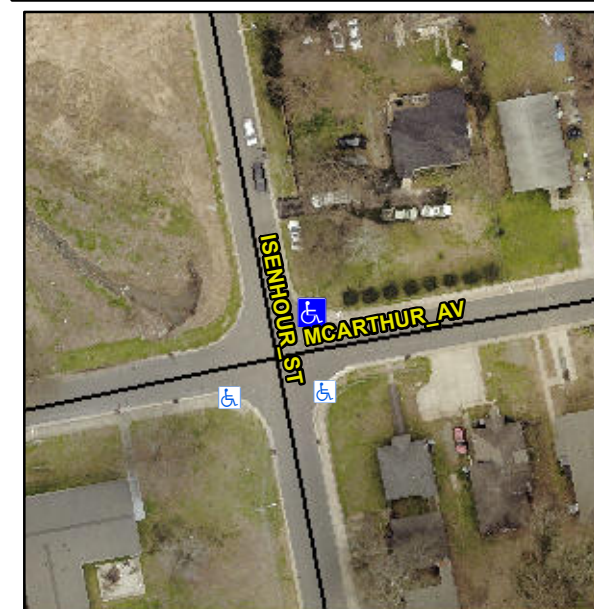
Not Found, R304.5.1, R304.2.2, R304.5.3

Compliance	Description	Data	Compliance	Description	Data
N/A	Ramp Length (in)	46.0	No	Ramp Slope (%)	12.0
No	Ramp Width (in)	32.0	No	Ramp XSlope (%)	5.6
N/A	Flare Type LT	N/A	N/A	Flare Type RT	N/A
N/A	Flare Slope LT (%)	N/A	N/A	Flare Slope RT (%)	N/A
N/A	Flare Traversable LT?	N/A	N/A	Flare Traversable RT?	N/A
N/A	Landing Length (in)	N/A	N/A	DWS Provided?	N/A
N/A	Landing Width (in)	N/A	N/A	DWS Contrast?	N/A
N/A	Landing Slope (%)	N/A	N/A	DWS Length (in)	N/A
N/A	Landing X Slope (%)	N/A	N/A	DWS Full Width?	N/A
N/A	Landing Curb? (Y/N)	N/A	N/A	DWS Offset (in)	N/A
N/A	Shared Landing?	N/A			
N/A	Gutter Ponding?	N/A	N/A	Gutter Slope (%)	N/A
N/A	Gutter Lip Ht (in)	N/A	N/A	Gutter X Slope (%)	N/A
N/A	Painted X Walk1?	No	N/A	Painted X Walk2?	N/A
	X Walk 1 Direction	To S		X Walk 2 Direction	N/A
N/A	X Walk 1 Width (in)	N/A	N/A	X Walk 2 Width (in)	N/A
	X Walk 1 Slope (%)	3.4		X Walk 2 Slope (%)	N/A
	X Walk 1 X Slope (%)	3.0		X Walk 2 X Slope (%)	N/A

N/A	Ramp inside XWalk1?	N/A	N/A	Ramp inside XWalk2?	N/A
	Road Slope (%)	N/A	N/A	Clear Space?	N/A
	Road X Slope (%)	N/A	N/A	Clear Space to XWalk (in)	N/A
N/A	Any Obstructions?	N/A	N/A	Storm Grate/Utility Hazard?	N/A
	Obstruction Type			Storm Grate/Utility Type	
		N/A			N/A
			Yes	Surface Condition? (G/P)	Good

Remove & Replace Entire Ramp.
