Access Compliance Report

Public Rights-of-Way

(Curb Ramps)

Intersection ID: 51358	Main Street: PIKE_RD	Cross Street: BRENTMOOR_DR	Location: NW
ADA ID: 225A9D86C2D1	Ramp Type: PerpDiag	Initial Pass/Fail: Fail	Overall Compliance: No
		Severity Score: 8.75

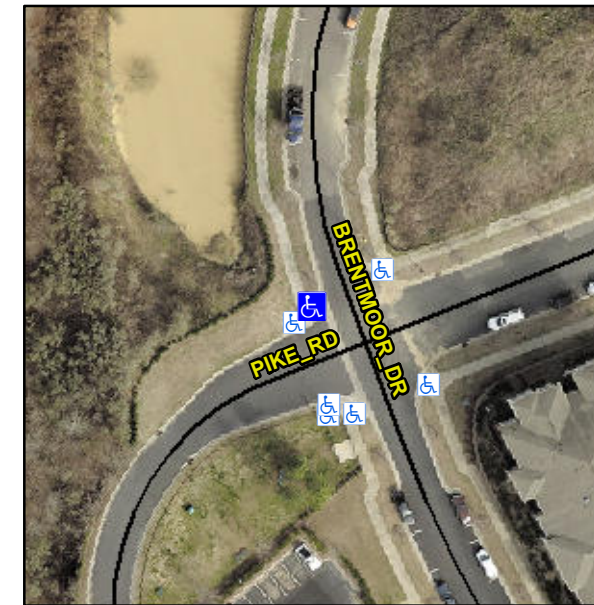
Not Found, R304.5.1

Compliance	Description	Data	Compliance	Description	Data
N/A	Ramp Length (in)	81.0	Yes	Ramp Slope (%)	5.5
No	Ramp Width (in)	46.0	Yes	Ramp XSlope (%)	0.5
N/A	Flare Type LT	N/A	N/A	Flare Type RT	N/A
N/A	Flare Slope LT (%)	N/A	N/A	Flare Slope RT (%)	N/A
N/A	Flare Traversable LT?	N/A	N/A	Flare Traversable RT?	N/A
N/A	Landing Length (in)	N/A	N/A	DWS Provided?	N/A
N/A	Landing Width (in)	N/A	N/A	DWS Contrast?	N/A
N/A	Landing Slope (%)	N/A	N/A	DWS Length (in)	N/A
N/A	Landing X Slope (%)	N/A	N/A	DWS Full Width?	N/A
N/A	Landing Curb? (Y/N)	N/A	N/A	DWS Offset (in)	N/A
N/A	Shared Landing?	N/A			
N/A	Gutter Ponding?	N/A	N/A	Gutter Slope (%)	N/A
N/A	Gutter Lip Ht (in)	N/A	N/A	Gutter X Slope (%)	N/A
N/A	Painted X Walk1?	No	N/A	Painted X Walk2?	No
	X Walk 1 Direction	To S		X Walk 2 Direction	To E
N/A	X Walk 1 Width (in)	N/A	N/A	X Walk 2 Width (in)	N/A
	X Walk 1 Slope (%)	0.8		X Walk 2 Slope (%)	4.3
	X Walk 1 X Slope (%)	2.8		X Walk 2 X Slope (%)	0.9

N/A	Ramp inside XWalk1?	N/A	N/A	Ramp inside XWalk2?	N/A
	Road Slope (%)	2.3	N/A	Clear Space?	N/A
	Road X Slope (%)	2.5	N/A	Clear Space to XWalk (in)	N/A
N/A	Any Obstructions?	N/A	N/A	Storm Grate/Utility Hazard?	N/A
	Obstruction Type			Storm Grate/Utility Type	
		N/A			N/A
			Yes	Surface Condition? (G/P)	Good

Possible Solutions:

Remove & Replace Curb Ramp With Two New Directional Ramps or Equivalent.
