Access Compliance Report

Public Rights-of-Way

(Curb Ramps)

Intersection ID: 18963	Main Street: GROVER_RD	Cross Street: SOUTH_BV	Location: NW
ADA ID: 2260D5834459	Ramp Type: PerpDiag	Initial Pass/Fail: Fail	Overall Compliance: No
Severity Score: 22.5			
Codes/Mitigation Info/Possible Solution		Field Measurements/Component Compliance

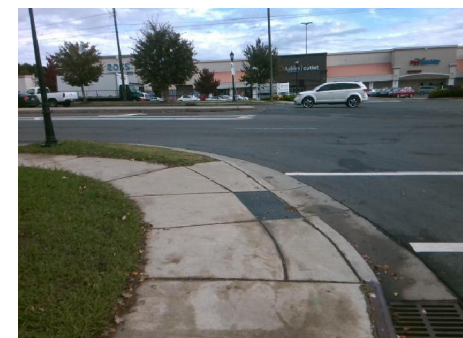
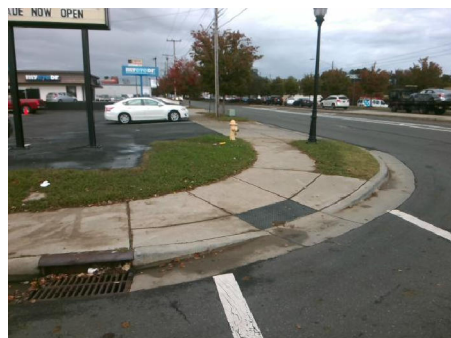
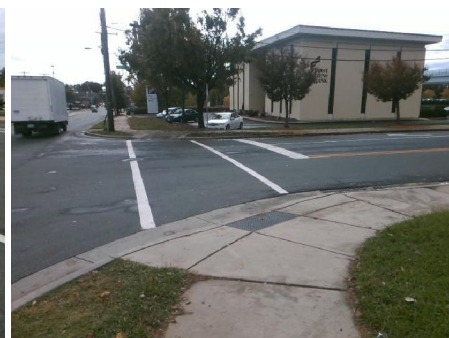
Compliance	Description	Data	Compliance	Description	Data
N/A	Ramp Length (in)	84.0	No	Ramp Slope (%)	9.6
No	Ramp Width (in)	47.0	No	Ramp XSlope (%)	2.3
N/A	Flare Type LT	N/A	N/A	Flare Type RT	N/A
N/A	Flare Slope LT (%)	N/A	N/A	Flare Slope RT (%)	N/A
N/A	Flare Traversable LT?	N/A	N/A	Flare Traversable RT?	N/A
N/A	Landing Length (in)	N/A	N/A	DWS Provided?	N/A
N/A	Landing Width (in)	N/A	N/A	DWS Contrast?	N/A
N/A	Landing Slope (%)	N/A	N/A	DWS Length (in)	N/A
N/A	Landing X Slope (%)	N/A	N/A	DWS Full Width?	N/A
N/A	Landing Curb? (Y/N)	N/A	N/A	DWS Offset (in)	N/A
N/A	Shared Landing?	N/A			
N/A	Gutter Ponding?	N/A	N/A	Gutter Slope (%)	N/A
N/A	Gutter Lip Ht (in)	N/A	N/A	Gutter X Slope (%)	N/A
N/A	Painted X Walk1?	Yes	N/A	Painted X Walk2?	No
	X Walk 1 Direction	To S		X Walk 2 Direction	To E
N/A	X Walk 1 Width (in)	110.0	N/A	X Walk 2 Width (in)	N/A
	X Walk 1 Slope (%)	1.7		X Walk 2 Slope (%)	1.2
	X Walk 1 X Slope (%)	1.1		X Walk 2 X Slope (%)	0.1

N/A	Ramp inside XWalk1?	Yes	N/A	Ramp inside XWalk2?	N/A
	Road Slope (%)	1.0	N/A	Clear Space?	N/A
	Road X Slope (%)	1.8	N/A	Clear Space to XWalk (in)	N/A
N/A	Any Obstructions?	N/A	N/A	Storm Grate/Utility Hazard?	N/A
	Obstruction Type			Storm Grate/Utility Type	
		N/A			N/A
		Yes		Surface Condition? (G/P)	Good

Possible Solutions:

Remove & Replace Curb Ramp With Two New Directional Ramps or Equivalent.
