## Access Compliance Report Public Rights-of-Way (Curb Ramps)

| · · · · | | | | | | | | | |
|---|---|---|---|---|--|---|---|---|---|
| Intersection ID: 16194 | Main Street: FERN_GLEN_CT | | | treet: | SPLIT_OAK_DR | Location: | SE | | |
| ADA ID: 22724F65D791 | Ramp Ty | Ramp Type: PerpDiag | | | Initial Pass/Fail: Fail Overall Compliance: No | | | | 13.75 |

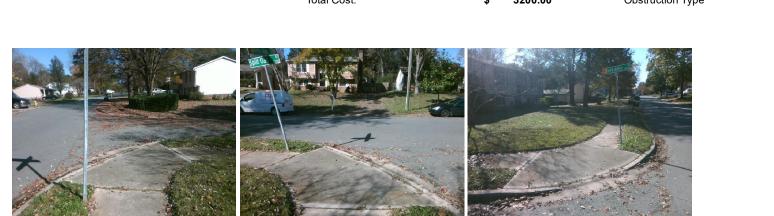
| · · · · | | | | | | | | | |
|---|---|---|---|---|--|---|---|---|---|
| | | Remove & Replace Curb Ramp W | lith | N/A | Ramp Length (in) | 95.0 | No | Ramp Slope (%) | 8.9 |
| | | Two New Directional Ramps or | | Yes | Ramp Width (in) | | No | Ramp XSlope (%) | 2.5 |
| | | Not Found, R304.2.2, R304.5.3 | | N/A | Gutter Lip Ht (in) | N/A | N/A | Gutter X Slope (%) | N/A |
| Street 1 Name | FERN GLEN CT | | | | X Walk 1 Slope (%) | 4.2 | | X Walk 2 Slope (%) | 10.9 |
| Stop Condition-Street 2 | StopSign | | | | X Walk 1 X Slope (%) | 6.3 | | X Walk 2 X Slope (%) | 2.7 |

| · · · · | | | | | | | | | |
|---|---|---|---|---|--|---|---|---|---|
| | | Possible Solutions: | | | | | | | |
| | | Equivalent. | | N/A | Flare Type LT | N/A | N/A | Flare Type RT | N/A |
| | | Total Cost: \$ 3 | 200.00 | | Obstruction Type | | | Storm Grate/Utility Type | |
