Access Compliance Report

Public Rights-of-Way

(Curb Ramps)

Intersection ID: 48492	Main Street: SHOPTON_RD_WEST	Cross Street: BEREWICK_COMMONS_PY	Location: SE
ADA ID: 227A0D85A87F	Ramp Type: Perp	Initial Pass/Fail: Fail	Overall Compliance: No
Severity Score: 8.75			
Codes/Mitigation Info/Possible Solution		Field Measurements/Component Compliance

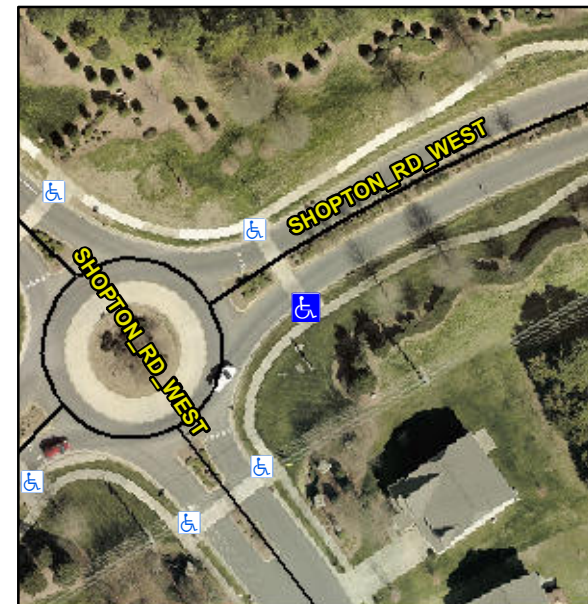
Not Found, R304.5.1

Compliance	Description	Data	Compliance	Description	Data
N/A	Ramp Length (in)	69.5	Yes	Ramp Slope (%)	5.6
No	Ramp Width (in)	47.0	Yes	Ramp XSlope (%)	0.8
N/A	Flare Type LT	N/A	N/A	Flare Type RT	N/A
N/A	Flare Slope LT (%)	N/A	N/A	Flare Slope RT (%)	N/A
N/A	Flare Traversable LT?	N/A	N/A	Flare Traversable RT?	N/A
N/A	Landing Length (in)	N/A	N/A	DWS Provided?	N/A
N/A	Landing Width (in)	N/A	N/A	DWS Contrast?	N/A
N/A	Landing Slope (%)	N/A	N/A	DWS Length (in)	N/A
N/A	Landing X Slope (%)	N/A	N/A	DWS Full Width?	N/A
N/A	Landing Curb? (Y/N)	N/A	N/A	DWS Offset (in)	N/A
N/A	Shared Landing?	N/A			
N/A	Gutter Ponding?	N/A	N/A	Gutter Slope (%)	N/A
N/A	Gutter Lip Ht (in)	N/A	N/A	Gutter X Slope (%)	N/A
N/A	Painted X Walk1?	Yes	N/A	Painted X Walk2?	N/A
	X Walk 1 Direction	To NW		X Walk 2 Direction	N/A
N/A	X Walk 1 Width (in)	94.0	N/A	X Walk 2 Width (in)	N/A
	X Walk 1 Slope (%)	0.6		X Walk 2 Slope (%)	N/A
	X Walk 1 X Slope (%)	0.9		X Walk 2 X Slope (%)	N/A

Possible Solutions:

Remove & Replace Entire Ramp.

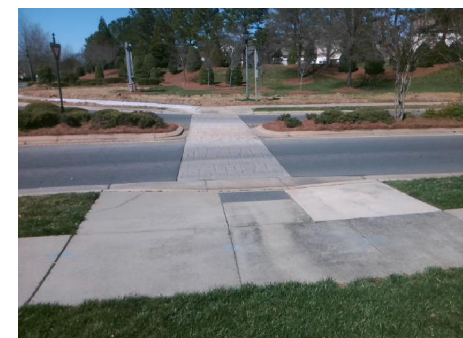
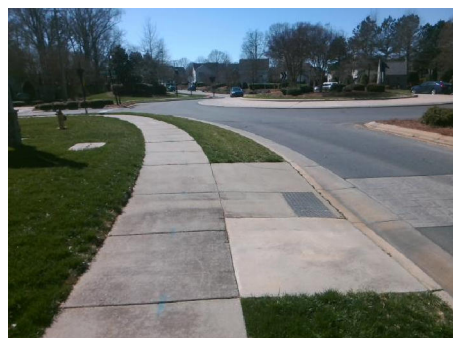
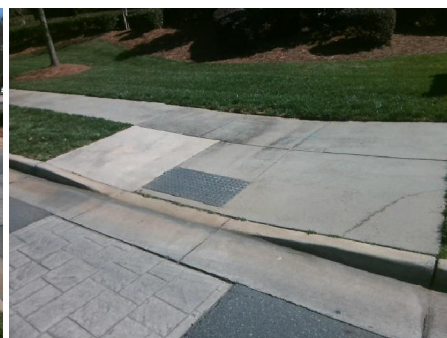
N/A	Ramp inside XWalk1?	Yes	N/A	Ramp inside XWalk2?	N/A
	Road Slope (%)	N/A	N/A	Clear Space?	N/A
	Road X Slope (%)	N/A	N/A	Clear Space to XWalk (in)	N/A
N/A	Any Obstructions?	N/A	N/A	Storm Grate/Utility Hazard?	N/A
	Obstruction Type			Storm Grate/Utility Type	
		N/A			N/A
			Yes	Surface Condition? (G/P)	Good
