Access Compliance Report

Public Rights-of-Way

(Curb Ramps)

Intersection ID: 21325	Main Street: RAMSGATE_RD	Cross Street: SARDIS_LN	Location: NW
ADA ID: 227D8142DC9D	Ramp Type: Directional1	Initial Pass/Fail: Fail	Overall Compliance: No
Severity Score: 1.25			
Codes/Mitigation Info/Possible Solution		Field Measurements/Component Compliance

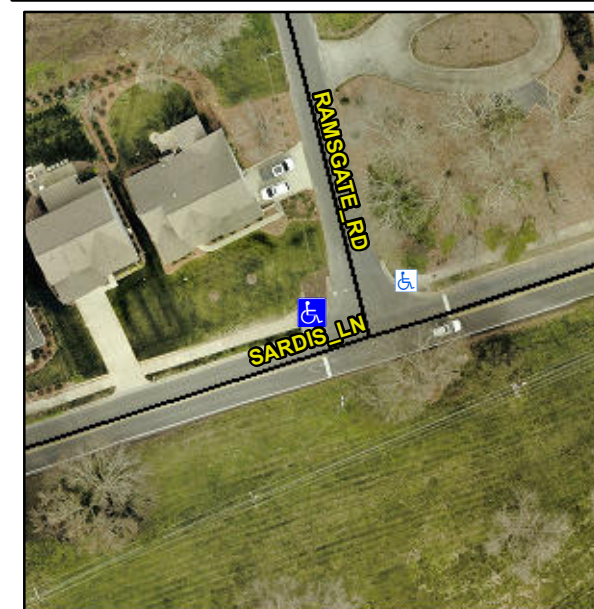
Compliance	Description	Data	Compliance	Description	Data
N/A	Ramp Length (in)	120.0	N/A	Grade Break?	N/A
Yes	Ramp Width (in)	65.0	N/A	Grade Break Slope (%)	0.0
Yes	Ramp Slope (%)	8.3	N/A	Grade Break XSlope (%)	0.0
No	Ramp XSlope (%)	2.5			
N/A	Flare Type LT	N/A	N/A	Flare Type RT	N/A
N/A	Flare Slope LT (%)	N/A	N/A	Flare Slope RT (%)	0.0
N/A	Flare Traversable LT?	N/A	N/A	Flare Traversable RT?	N/A
N/A	Landing Length (in)	0.0	N/A	DWS Provided?	N/A
N/A	Landing Width (in)	0.0	N/A	DWS Contrast?	N/A
N/A	Landing Slope (%)	0.0	N/A	DWS Length (in)	N/A
N/A	Landing X Slope (%)	0.0	N/A	DWS Full Width?	N/A
N/A	Landing Curb? (Y/N)	N/A	N/A	DWS Offset LT (in)	N/A
N/A	Shared Landing?	N/A	N/A	DWS Offset RT (in)	N/A
N/A	Gutter Ponding?	0.0	N/A	Gutter Slope (%)	N/A
N/A	Gutter Lip Ht (in)	0.0	N/A	Gutter X Slope (%)	N/A
N/A	Painted X Walk1?	No		Road Slope (%)	2.9
	X Walk 1 Direction	To NE		Road X Slope (%)	0.0
	X Walk 1 Width (in)	N/A		Clear Space?	N/A

X Walk 1 Slope (%)	2.9	N/A	Clear Space to XWalk (in)	N/A
	X Walk 1 X Slope (%)	0.0	N/A	Storm Grate/Utility Hazard?	N/A
N/A	Ramp inside XWalk1?	N/A		Storm Grate/Utility Type	
N/A	Any Obstructions?	N/A			N/A
	Obstruction Type		Yes	Surface Condition? (G/P)	Good
			N/A	Curb Slope (%)	3.1

Possible Solutions:

Remove & Replace Entire Ramp.

R304.5.3
