Access Compliance Report

Public Rights-of-Way

(Curb Ramps)

| Intersection ID: 15546 | Main Street: CONISTON_PL | Cross Street: QUEENS_RD_WEST | Location: NW |

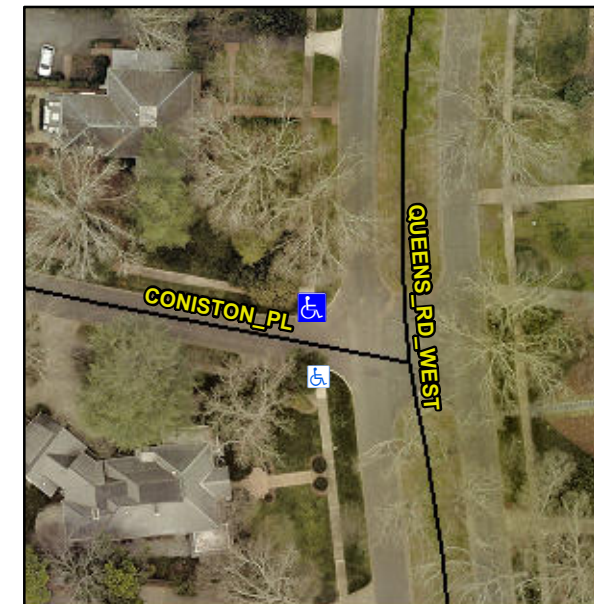
NO CURB LINE, MEDIAN ACROSS QUEENS RD WEST

R304.5.3

| Compliance | Description | Data | Compliance | Description | Data |
|---|---|---|---|---|---|
| No | Ramp XSlope (%) | 2.2 | | | |

Remove & Replace Entire Ramp.
