## Access Compliance Report Public Rights-of-Way (Curb Ramps)

Intersection ID: 53380 Main Street: IKEA\_BV Cross Street: LEWIS\_ST Location: W

ADA ID: 2286CFDE6F7D Ramp Type: Perp Initial Pass/Fail: Pass Overall Compliance: No Severity Score:

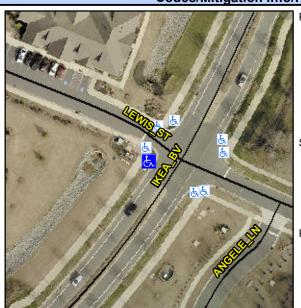
Street 1 Name IKEA BV
Stop Condition-Street 2 None
Street 2 Name N/A
Stop Condition-Street 1 N/A

ООПІРІ	idiloc Description	Butu	ООПІР	nance Description	Dutu
N/A	Ramp Length (in)	95.0	Yes	Ramp Slope (%)	8.3
Yes	Ramp Width (in)	59.0	Yes	Ramp XSlope (%)	0.6
Yes	Flare Type L <b>Curbed_NoW</b>	alkSurface	Yes	Flare Type RT	N/A
Yes	Flare Slope LT (%)	N/A	N/A	Flare Slope RT (%)	N/A
N/A	Flare Traversable LT?	No	N/A	Flare Traversable RT?	No
Yes	Landing Length (in)	96.0	Yes	DWS Provided?	Yes
Yes	Landing Width (in)	71.0	Yes	DWS Contrast?	Yes
Yes	Landing Slope (%)	1.2	Yes	DWS Length (in)	24.0
Yes	Landing X Slope (%)	0.4	Yes	DWS Full Width?	Yes
N/A	Landing Curb? (Y/N)	No	Yes	DWS Offset (in)	1.0
N/A	Shared Landing?	Yes			
No	Gutter Ponding?	Yes	No	Gutter Slope (%)	6.0
Yes	Gutter Lip Ht (in)	0.0	Yes	Gutter X Slope (%)	2.6
N/A	Painted X Walk1?	Yes	N/A	Painted X Walk2?	N/A
	X Walk 1 Direction	To SE		X Walk 2 Direction	N/A
N/A	X Walk 1 Width (in)	60.0	N/A	X Walk 2 Width (in)	N/A
	X Walk 1 Slope (%)	2.4		X Walk 2 Slope (%)	N/A

X Walk 1 X Slope (%)	3.3		X Walk 2 X Slope (%)	N/A
Yes	Ramp inside XWalk1?	Yes	N/A	Ramp inside XWalk2?	N/A
	Road Slope (%)	N/A	N/A	Clear Space?	Yes
	Road X Slope (%)	N/A	N/A	Clear Space to XWalk (in)	N/A
Yes	Any Obstructions?	No	Yes	Storm Grate/Utility Hazard?	No
	Obstruction Type			Storm Grate/Utility Type	
		N/A			N/A
			Yes	Surface Condition? (G/P)	Good

. 000:0:0 00:0:::						
Possible Solutions:						
Remove & Replace Entire Ramp. Remove & Replace Gutter.						
Surveyor Notes:						
N/A						
PROW/ADA:						
Not Found, R302.7, R304.5.4

N/A		
PROW/ADA:			No		
Not Found, R302.7, R304.5.4					
			N/A		
			N/A		
			Yes		
Total Cost:	\$	2600.00	Yes
