# Access Compliance Report

## Public Rights-of-Way

### (Curb Ramps)

Intersection ID: 8941	Main Street: ORVIS_ST	Cross Street: RUSSELL_AV	Location:	E
ADA ID: 228C3CBB7748	Ramp Type: Perp	Initial Pass/Fail: Fail	Overall Compliance: No	Severity Score: 8.75

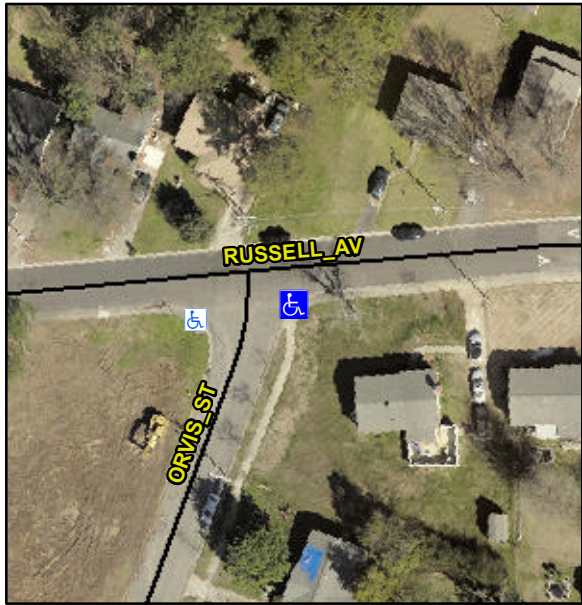
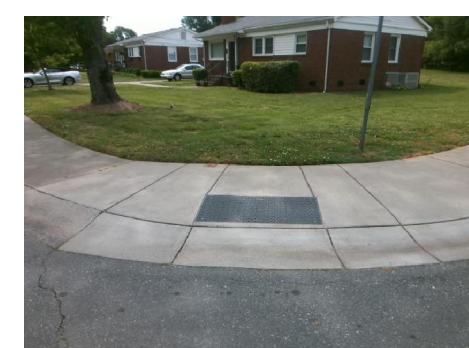
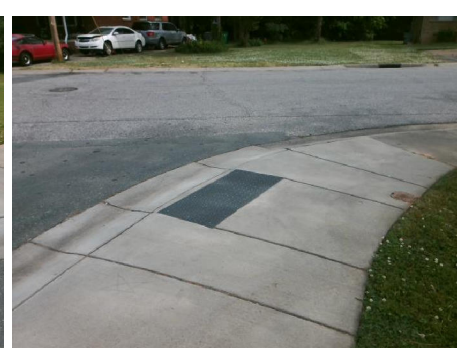
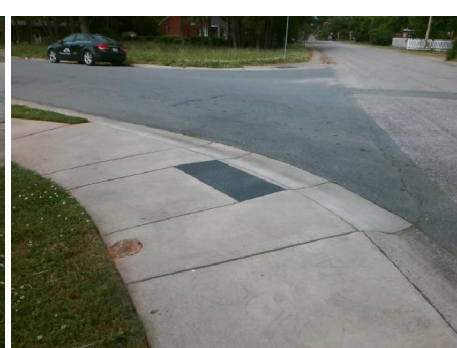
Possible Solutions:		<b>Compliance</b>	<b>Description</b>	<b>Data</b>	<b>Compliance</b>	<b>Description</b>	<b>Data</b>
	<b>Remove &amp; Replace Entire Ramp.</b>		N/A	Ramp Length (in)	27.5	Yes	Ramp Slope (%)	6.8
			No	Ramp Width (in)	46.5	Yes	Ramp XSlope (%)	1.8
			N/A	Flare Type LT	N/A	N/A	Flare Type RT	N/A
			N/A	Flare Slope LT (%)	N/A	N/A	Flare Slope RT (%)	N/A
			N/A	Flare Traversable LT?	N/A	N/A	Flare Traversable RT?	N/A
			N/A	Landing Length (in)	N/A	N/A	DWS Provided?	N/A
			N/A	Landing Width (in)	N/A	N/A	DWS Contrast?	N/A
			N/A	Landing Slope (%)	N/A	N/A	DWS Length (in)	N/A
			N/A	Landing X Slope (%)	N/A	N/A	DWS Full Width?	N/A
Surveyor Notes:			N/A	Landing Curb? (Y/N)	N/A	N/A	DWS Offset (in)	N/A
<b>N/A</b>			N/A	Shared Landing?	N/A			
PROW/ADA:			N/A	Gutter Ponding?	N/A	N/A	Gutter Slope (%)	N/A
<b>Not Found, R304.5.1</b>			N/A	Gutter Lip Ht (in)	N/A	N/A	Gutter X Slope (%)	N/A

N/A	Painted X Walk1?	No	N/A	Painted X Walk2?	N/A
				X Walk 1 Direction	To SW		X Walk 2 Direction	N/A
			N/A	X Walk 1 Width (in)	N/A	N/A	X Walk 2 Width (in)	N/A
				X Walk 1 Slope (%)	0.9		X Walk 2 Slope (%)	N/A
				X Walk 1 X Slope (%)	1.7		X Walk 2 X Slope (%)	N/A
			N/A	Ramp inside XWalk1?	N/A	N/A	Ramp inside XWalk2?	N/A
				Road Slope (%)	N/A	N/A	Clear Space?	N/A
				Road X Slope (%)	N/A	N/A	Clear Space to XWalk (in)	N/A
			N/A	Any Obstructions?	N/A	N/A	Storm Grate/Utility Hazard?	N/A
				Obstruction Type			Storm Grate/Utility Type	
						N/A		N/A
						Yes	Surface Condition? (G/P)	Good
Total Cost:		\$ 1850.00						
Street 1 Name		ORVIS ST						
Stop Condition-Street 2		StopSign						
Street 2 Name		N/A						
Stop Condition-Street 1		N/A
