# Access Compliance Report

## Public Rights-of-Way (Curb Ramps)

Intersection ID: N/A	Main Street: SPRINGWOOD_ESTATE_DR	Cross Street: SAGMORE_HILL_DR	Location: SW
ADA ID: 228CEE5B55DD	Ramp Type: BlendTrans1	Initial Pass/Fail: Fail	Overall Compliance: No
Codes/Mitigation Info/Possible Solution		Field Measurements/Component Compliance

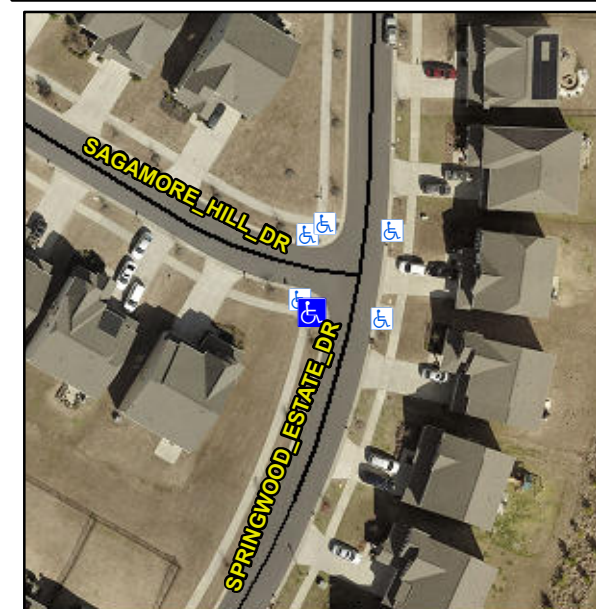
**Not Found, R304.5.1, R304.5.3**

Compliance	Description	Data	Compliance	Description	Data
N/A	Ramp Length (in)	99.0	Yes	BlendTrans Slope (%)	3.6
No	Ramp Width (in)	42.0	No	BlendTrans XSlope (%)	11.9
N/A	Flare Type LT	N/A	N/A	Flare Type RT	N/A
N/A	Flare Slope LT (%)	N/A	N/A	Flare Slope RT (%)	N/A
N/A	Flare Traversable LT?	N/A	N/A	Flare Traversable RT?	N/A
N/A	Landing Length (in)	N/A	N/A	DWS Provided?	N/A
N/A	Landing Width (in)	N/A	N/A	DWS Contrast?	N/A
N/A	Landing Slope (%)	N/A	N/A	DWS Length (in)	N/A
N/A	Landing X Slope (%)	N/A	N/A	DWS Full Width?	N/A
N/A	Landing Curb? (Y/N)	N/A	N/A	DWS Offset (in)	N/A
N/A	Shared Landing?	N/A			
N/A	Gutter Ponding?	N/A	N/A	Gutter Slope (%)	N/A
N/A	Gutter Lip Ht (in)	N/A	N/A	Gutter X Slope (%)	N/A
N/A	Painted X Walk1?	No	N/A	Painted X Walk2?	N/A
	X Walk 1 Direction	To E		X Walk 2 Direction	N/A
	X Walk 1 Width (in)	N/A		X Walk 2 Width (in)	N/A
	X Walk 1 Slope (%)	3.1		X Walk 2 Slope (%)	N/A
	X Walk 1 X Slope (%)	5.3		X Walk 2 X Slope (%)	N/A

N/A	Ramp inside XWalk1?	N/A	N/A	Ramp inside XWalk2?	N/A
	Road Slope (%)	5.3		Clear Space?	N/A
	Road X Slope (%)	3.1	N/A	Clear Space to XWalk (in)	N/A
N/A	Any Obstructions?	N/A	N/A	Storm Grate/Utility Hazard?	N/A
	Obstruction Type			Storm Grate/Utility Type	
		N/A			N/A
			Yes	Surface Condition? (G/P)	Good
			No	Curb Slope (%)	10.2

**Remove & Replace Curb Ramp With Two New Directional Ramps or Equivalent.**

Total Cost: \$ 3200.00
