# Access Compliance Report

## Public Rights-of-Way

### (Curb Ramps)

Intersection ID: 30513	Main Street: S_TRYON_ST	Cross Street: GENERAL_DR	Location: SE
ADA ID: 228F0FA16259	Ramp Type: PerpDiag	Initial Pass/Fail: Fail	Overall Compliance: No
Severity Score: 21.25			
Codes/Mitigation Info/Possible Solution		Field Measurements/Component Compliance

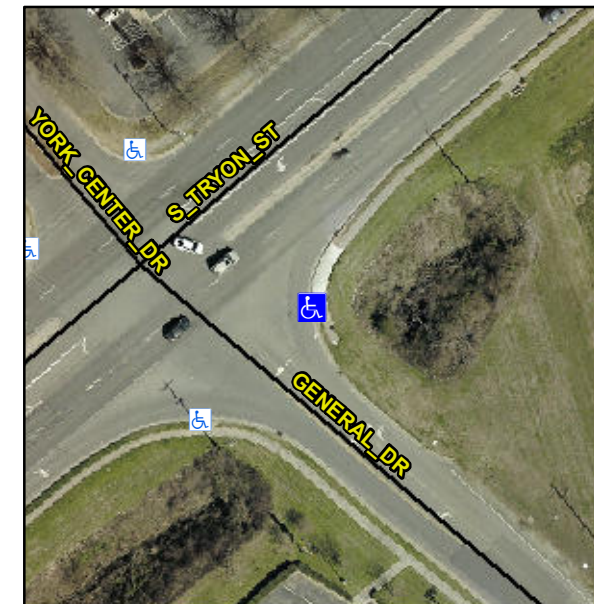
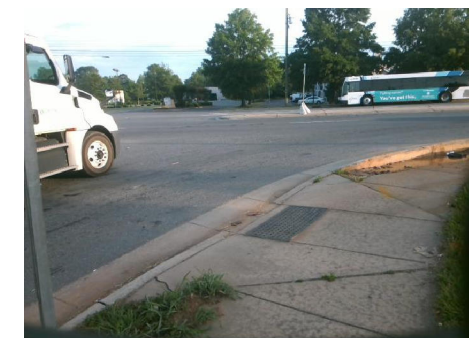
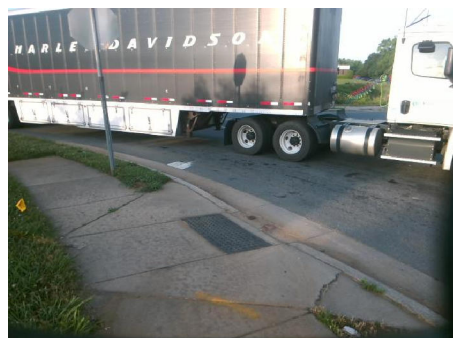
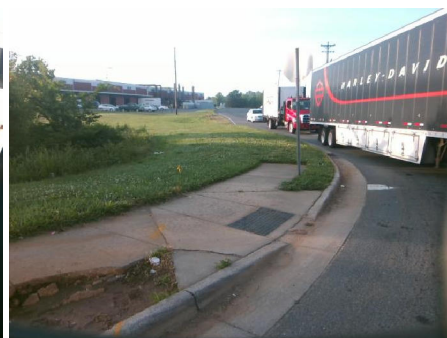
Compliance	Description	Data	Compliance	Description	Data
N/A	Ramp Length (in)	90.0	No	Ramp Slope (%)	8.6
No	Ramp Width (in)	44.0	Yes	Ramp XSlope (%)	1.8
N/A	Flare Type LT	N/A	N/A	Flare Type RT	N/A
N/A	Flare Slope LT (%)	N/A	N/A	Flare Slope RT (%)	N/A
N/A	Flare Traversable LT?	N/A	N/A	Flare Traversable RT?	N/A
N/A	Landing Length (in)	N/A	N/A	DWS Provided?	N/A
N/A	Landing Width (in)	N/A	N/A	DWS Contrast?	N/A
N/A	Landing Slope (%)	N/A	N/A	DWS Length (in)	N/A
N/A	Landing X Slope (%)	N/A	N/A	DWS Full Width?	N/A
N/A	Landing Curb? (Y/N)	N/A	N/A	DWS Offset (in)	N/A
N/A	Shared Landing?	N/A			
N/A	Gutter Ponding?	N/A	N/A	Gutter Slope (%)	N/A
N/A	Gutter Lip Ht (in)	N/A	N/A	Gutter X Slope (%)	N/A
N/A	Painted X Walk1?	No	N/A	Painted X Walk2?	No
	X Walk 1 Direction	To NW		X Walk 2 Direction	To SW
N/A	X Walk 1 Width (in)	N/A	N/A	X Walk 2 Width (in)	N/A
	X Walk 1 Slope (%)	0.5		X Walk 2 Slope (%)	2.2
	X Walk 1 X Slope (%)	2.3		X Walk 2 X Slope (%)	1.2

N/A	Ramp inside XWalk1?	N/A	N/A	Ramp inside XWalk2?	N/A
	Road Slope (%)	2.3	N/A	Clear Space?	N/A
	Road X Slope (%)	2.2	N/A	Clear Space to XWalk (in)	N/A
N/A	Any Obstructions?	N/A	N/A	Storm Grate/Utility Hazard?	N/A
	Obstruction Type			Storm Grate/Utility Type	
		N/A			N/A
			Yes	Surface Condition? (G/P)	Good

**Remove & Replace Curb Ramp With Two New Directional Ramps or Equivalent.**

**R304.5.1, R304.2.2**
