# Access Compliance Report

## Public Rights-of-Way

### (Curb Ramps)

Intersection ID: N/A	Main Street: RIVERGATE_VIEW_DR	Cross Street: WALKER_BRANCH_DR	Location: SW
ADA ID: 2294AC264BE9	Ramp Type: PerpDiag	Initial Pass/Fail: Fail	Overall Compliance: No
Severity Score: 22.5			
Codes/Mitigation Info/Possible Solution		Field Measurements/Component Compliance

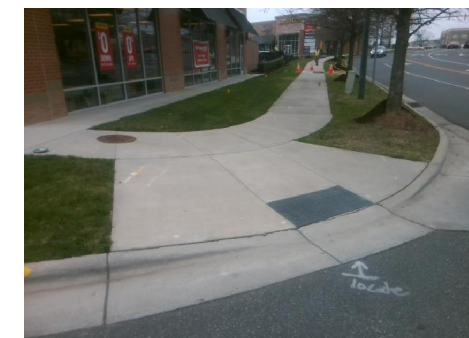
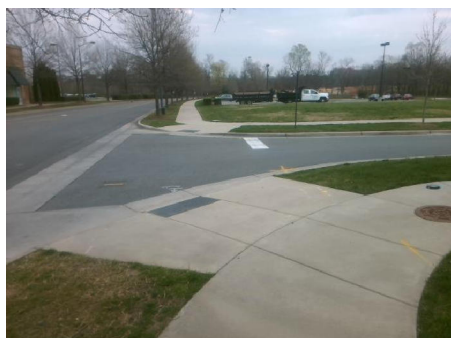
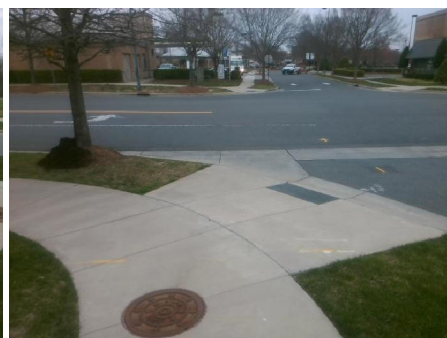
**Not Found, R304.5.1, R304.2.2, R304.5.3**

Compliance	Description	Data	Compliance	Description	Data
N/A	Ramp Length (in)	96.0	No	Ramp Slope (%)	10.0
No	Ramp Width (in)	44.5	No	Ramp XSlope (%)	3.5
N/A	Flare Type LT	N/A	N/A	Flare Type RT	N/A
N/A	Flare Slope LT (%)	N/A	N/A	Flare Slope RT (%)	N/A
N/A	Flare Traversable LT?	N/A	N/A	Flare Traversable RT?	N/A
N/A	Landing Length (in)	N/A	N/A	DWS Provided?	N/A
N/A	Landing Width (in)	N/A	N/A	DWS Contrast?	N/A
N/A	Landing Slope (%)	N/A	N/A	DWS Length (in)	N/A
N/A	Landing X Slope (%)	N/A	N/A	DWS Full Width?	N/A
N/A	Landing Curb? (Y/N)	N/A	N/A	DWS Offset (in)	N/A
N/A	Shared Landing?	N/A			
N/A	Gutter Ponding?	N/A	N/A	Gutter Slope (%)	N/A
N/A	Gutter Lip Ht (in)	N/A	N/A	Gutter X Slope (%)	N/A
N/A	Painted X Walk1?	No	N/A	Painted X Walk2?	No
	X Walk 1 Direction	To E		X Walk 2 Direction	To N
N/A	X Walk 1 Width (in)	N/A	N/A	X Walk 2 Width (in)	N/A
	X Walk 1 Slope (%)	1.6		X Walk 2 Slope (%)	4.4
	X Walk 1 X Slope (%)	3.1		X Walk 2 X Slope (%)	0.9

N/A	Ramp inside XWalk1?	N/A	N/A	Ramp inside XWalk2?	N/A
	Road Slope (%)	1.8	N/A	Clear Space?	N/A
	Road X Slope (%)	2.1	N/A	Clear Space to XWalk (in)	N/A
N/A	Any Obstructions?	N/A	N/A	Storm Grate/Utility Hazard?	N/A
	Obstruction Type			Storm Grate/Utility Type	
		N/A			N/A
			Yes	Surface Condition? (G/P)	Good

**Remove & Replace Curb Ramp With Two New Directional Ramps or Equivalent.**
