## Access Compliance Report Public Rights-of-Way (Curb Ramps)

Intersection ID: 27200Main Street: ANNALEXA\_LNCross Street: BALLANTYNE\_COMMONS\_PYLocation:SWADA ID: 2296A82B99F7Ramp Type: PerpInitial Pass/Fail: FailOverall Compliance: NoSeverity Score: 33.75

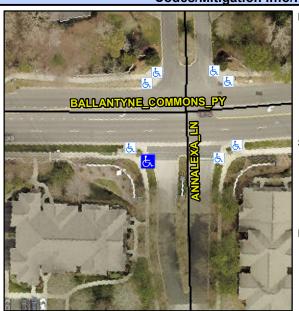
Not Found, R304.5.1, R304.5.3

Field Measurements/Component Compliance					
Compliance Description		Data	Comp	liance Description	Data
N/A	Ramp Length (in)	96.0	Yes	Ramp Slope (%)	6.4
No	Ramp Width (in)	37.0	No	Ramp XSlope (%)	8.7
N/A	Flare Type LT	N/A	N/A	Flare Type RT	N/A
N/A	Flare Slope LT (%)	N/A	N/A	Flare Slope RT (%)	N/A
N/A	Flare Traversable LT?	N/A	N/A	Flare Traversable RT?	N/A
N/A	Landing Length (in)	N/A	N/A	DWS Provided?	N/A
N/A	Landing Width (in)	N/A	N/A	DWS Contrast?	N/A
N/A	Landing Slope (%)	N/A	N/A	DWS Length (in)	N/A
N/A	Landing X Slope (%)	N/A	N/A	DWS Full Width?	N/A
N/A	Landing Curb? (Y/N)	N/A	N/A	DWS Offset (in)	N/A
N/A	Shared Landing?	N/A			
N/A	Gutter Ponding?	N/A	N/A	Gutter Slope (%)	N/A
N/A	Gutter Lip Ht (in)	N/A	N/A	Gutter X Slope (%)	N/A
N/A	Painted X Walk1?	No	N/A	Painted X Walk2?	N/A
	X Walk 1 Direction	To SE		X Walk 2 Direction	N/A
N/A	X Walk 1 Width (in)	N/A	N/A	X Walk 2 Width (in)	N/A
	X Walk 1 Slope (%)	2.1		X Walk 2 Slope (%)	N/A

X Walk 1 X Slope (%)	8.1		X Walk 2 X Slope (%)	N/A
N/A	Ramp inside XWalk1?	N/A	N/A	Ramp inside XWalk2?	N/A
	Road Slope (%)	N/A	N/A	Clear Space?	N/A
	Road X Slope (%)	N/A	N/A	Clear Space to XWalk (in)	N/A
N/A	Any Obstructions?	N/A	N/A	Storm Grate/Utility Hazard?	N/A
	Obstruction Type			Storm Grate/Utility Type	
		N/A			N/A
			Yes	Surface Condition? (G/P)	Good
	1/

Remove & Replace Entire Ramp.
