Access Compliance Report

Public Rights-of-Way

(Curb Ramps)

Intersection ID: 4615	Main Street: CLAIREMORE_PL	Cross Street: TRINITY_RD	Location: NW
ADA ID: 229C9570385C	Ramp Type: Perp	Initial Pass/Fail: Fail	Overall Compliance: No
Severity Score: 21.25			
Codes/Mitigation Info/Possible Solution		Field Measurements/Component Compliance

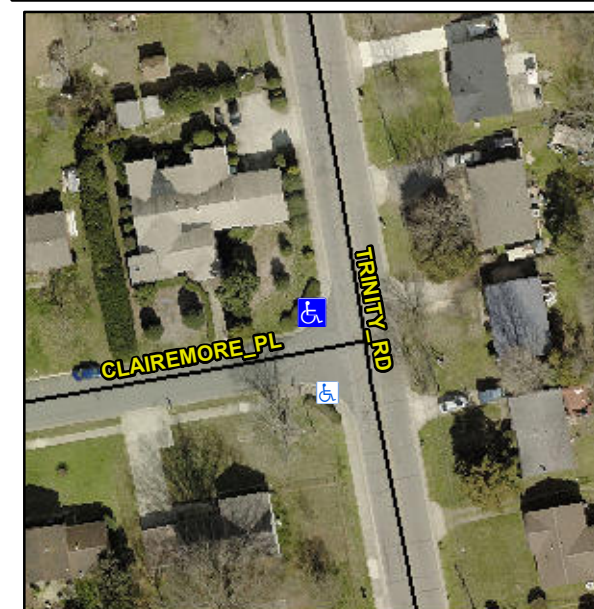
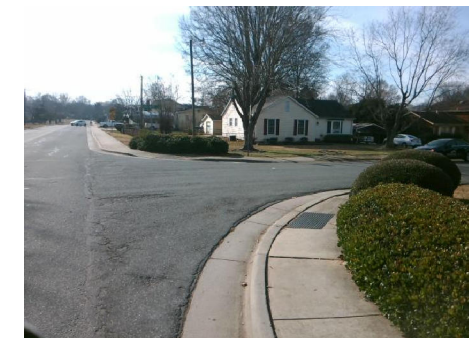
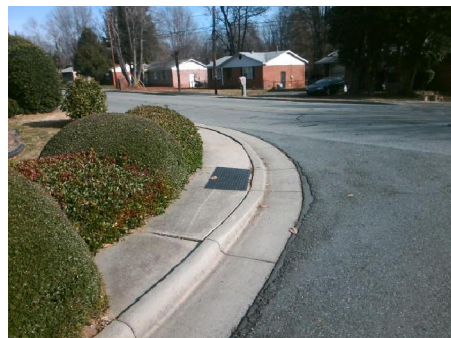
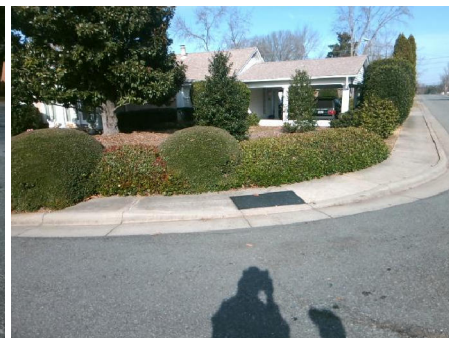
R304.5.1, R304.2.2

Compliance	Description	Data	Compliance	Description	Data
N/A	Ramp Length (in)	47.5	No	Ramp Slope (%)	9.5
No	Ramp Width (in)	40.5	Yes	Ramp XSlope (%)	2.0
N/A	Flare Type LT	N/A	N/A	Flare Type RT	N/A
N/A	Flare Slope LT (%)	N/A	N/A	Flare Slope RT (%)	N/A
N/A	Flare Traversable LT?	N/A	N/A	Flare Traversable RT?	N/A
N/A	Landing Length (in)	N/A	N/A	DWS Provided?	N/A
N/A	Landing Width (in)	N/A	N/A	DWS Contrast?	N/A
N/A	Landing Slope (%)	N/A	N/A	DWS Length (in)	N/A
N/A	Landing X Slope (%)	N/A	N/A	DWS Full Width?	N/A
N/A	Landing Curb? (Y/N)	N/A	N/A	DWS Offset (in)	N/A
N/A	Shared Landing?	N/A			
N/A	Gutter Ponding?	N/A	N/A	Gutter Slope (%)	N/A
N/A	Gutter Lip Ht (in)	1.0	N/A	Gutter X Slope (%)	N/A
N/A	Painted X Walk1?	No	N/A	Painted X Walk2?	N/A
	X Walk 1 Direction	To S		X Walk 2 Direction	N/A
N/A	X Walk 1 Width (in)	N/A	N/A	X Walk 2 Width (in)	N/A
	X Walk 1 Slope (%)	0.3		X Walk 2 Slope (%)	N/A
	X Walk 1 X Slope (%)	1.4		X Walk 2 X Slope (%)	N/A

N/A	Ramp inside XWalk1?	N/A	N/A	Ramp inside XWalk2?	N/A
	Road Slope (%)	N/A	N/A	Clear Space?	N/A
	Road X Slope (%)	N/A	N/A	Clear Space to XWalk (in)	N/A
N/A	Any Obstructions?	N/A	N/A	Storm Grate/Utility Hazard?	N/A
	Obstruction Type			Storm Grate/Utility Type	
		N/A			N/A
			Yes	Surface Condition? (G/P)	Good

Remove & Replace Entire Ramp.
