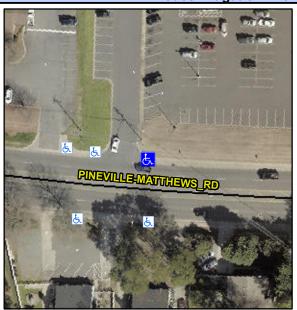
3200.00

Field Measurements/Component Compliance						
Compliance Description		Data	Comp	liance Description	Data	
N/A	Ramp Length (in)	62.0	No	Ramp Slope (%)	10.3	
No	Ramp Width (in)	40.0	No	Ramp XSlope (%)	3.7	
N/A	Flare Type LT	N/A	N/A	Flare Type RT	N/A	
N/A	Flare Slope LT (%)	N/A	N/A	Flare Slope RT (%)	N/A	
N/A	Flare Traversable LT?	N/A	N/A	Flare Traversable RT?	N/A	
N/A	Landing Length (in)	N/A	N/A	DWS Provided?	N/A	
N/A	Landing Width (in)	N/A	N/A	DWS Contrast?	N/A	
N/A	Landing Slope (%)	N/A	N/A	DWS Length (in)	N/A	
N/A	Landing X Slope (%)	N/A	N/A	DWS Full Width?	N/A	
N/A	Landing Curb? (Y/N)	N/A	N/A	DWS Offset (in)	N/A	
N/A	Shared Landing?	N/A				
N/A	Gutter Ponding?	N/A	N/A	Gutter Slope (%)	N/A	
N/A	Gutter Lip Ht (in)	N/A	N/A	Gutter X Slope (%)	N/A	
N/A	Painted X Walk1?	No	N/A	Painted X Walk2?	No	
	X Walk 1 Direction	To W		X Walk 2 Direction	To S	
N/A	X Walk 1 Width (in)	N/A	N/A	X Walk 2 Width (in)	N/A	
	X Walk 1 Slope (%)	0.5		X Walk 2 Slope (%)	2.9

Street 1 Name ENTRANCE
Stop Condition-Street 2 None
Street 2 Name PINEVILLE-MATTHEWS RD
Stop Condition-Street 1 None
