Access Compliance Report Public Rights-of-Way (Curb Ramps)

Intersection ID: 4335	3357 Main Street: PROSPERITY_VIEW_DR			Street:	WOODLAND_COMMO	Location:	Ν		
ADA ID: 22B6F9A156	Ramp Type: PerpDiag			Initial Pass/Fail: Fail Overall Compliance: No				o Severity Score:	10
Codes/Mitigation Info/Possible Solution				Field Measurements/Component Compliance					
		Possible Solutions:		Compliance Description		Data	Data Compliance Description		
Anni		Remove & Replace Curb Ramp W Two New Directional Ramps or Equivalent.	With	N/A	Ramp Length (in)	48.0	Yes	Ramp Slope (%)	7.6
and the F				No	Ramp Width (in)	42.0	No	Ramp XSlope (%)	4.7
1 Mark				N/A	Flare Type LT	N/A	N/A	Flare Type RT	N/A
				N/A	Flare Slope LT (%)	N/A	N/A	Flare Slope RT (%)	N/A
				N/A	Flare Traversable LT?	N/A	N/A	Flare Traversable RT?	N/A
S My Lon				N/A	Landing Length (in)	N/A	N/A	DWS Provided?	N/A
		Surveyor Notes:		N/A	Landing Width (in)	N/A	N/A	DWS Contrast?	N/A
Piloon	ES I I I I I I I I I I I I I I I I I I I	N/A		N/A	Landing Slope (%)	N/A	N/A	DWS Length (in)	N/A

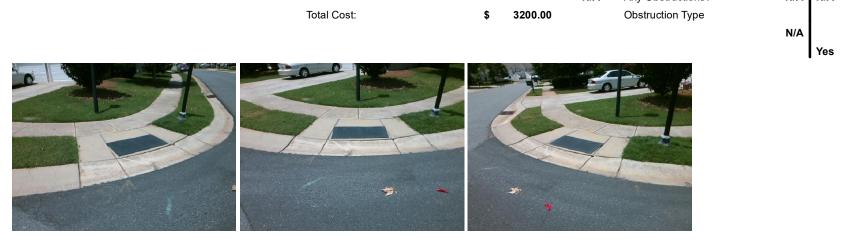
RITY 1			N/A	Landing X Slope (%)	N/A	N/A	DWS Full Width?	N/A
Too Charles	E.			N/A	Landing Curb? (Y/N)	N/A	N/A	DWS Offset (in)	N/A
MAR AND AND	6			N/A	Shared Landing?	N/A		ζ, γ	
MARIAN		PROW/ADA:		N/A	Gutter Ponding?	N/A	N/A	Gutter Slope (%)	N/A
	TTAL	Not Found, R304.5.1, R304.5.3		N/A	Gutter Lip Ht (in)	N/A	N/A	Gutter X Slope (%)	N/A
A CARTON HOUSE				N/A	Painted X Walk1?	No	N/A	Painted X Walk2?	No
					X Walk 1 Direction	To SW		X Walk 2 Direction	To SE
				N/A	X Walk 1 Width (in)	N/A	N/A	X Walk 2 Width (in)	N/A
Street 1 Name	PROSPERITY VIEW DR	-			X Walk 1 Slope (%)	2.9		X Walk 2 Slope (%)	0.6
Stop Condition-Street 2	None				X Walk 1 X Slope (%)	2.1		X Walk 2 X Slope (%)	1.6
Street 2 Name	WODLAND COMMONS DR			N/A	Ramp inside XWalk1?	N/A	N/A	Ramp inside XWalk2?	N/A
Stop Condition-Street 1	StopSign				Road Slope (%)	1.4	N/A	Clear Space?	N/A
					Road X Slope (%)	3.5	N/A	Clear Space to XWalk (in)	N/A
				N/A	Any Obstructions?	N/A	N/A	Storm Grate/Utility Hazard?	N/A

Good

Total Cost: \$	3200.00		Obstruction Type			Storm Grate/Utility Type	
						N/A			N/A
							-
