Access Compliance Report Public Rights-of-Way (Curb Ramps)

Intersection ID: 23851 Main Street: BOLINGBROOK LN **Cross Street: CARTGATE LN** Location: NW ADA ID: 22B96854114F Ramp Type: PerpDiag Initial Pass/Fail: Fail **Overall Compliance: No** Severity Score: 33.75

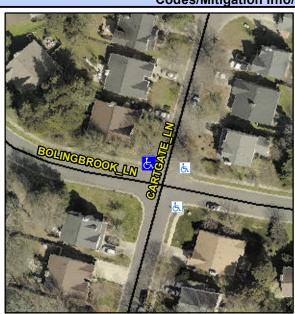
R304.5.1, R304.2.2

Com	oliance Description	Data	Comp	liance	Description	Data
N/A	Ramp Length (in)	94.0	No	Ramp	Slope (%)	12.5
No	Ramp Width (in)	42.0	Yes	Ramp	XSlope (%)	1.6
N/A	Flare Type LT	N/A	N/A	Flare	Type RT	N/A
N/A	Flare Slope LT (%)	N/A	N/A	Flare	Slope RT (%)	N/A
N/A	Flare Traversable LT?	N/A	N/A	Flare	Traversable RT?	N/A
N/A	Landing Length (in)	N/A	N/A	DWS	Provided?	N/A
N/A	Landing Width (in)	N/A	N/A	DWS	Contrast?	N/A
N/A	Landing Slope (%)	N/A	N/A	DWS	Length (in)	N/A
N/A	Landing X Slope (%)	N/A	N/A	DWS	Full Width?	N/A
N/A	Landing Curb? (Y/N)	N/A	N/A	DWS	Offset (in)	N/A
N/A	Shared Landing?	N/A				
N/A	Gutter Ponding?	N/A	N/A	Gutter	Slope (%)	N/A
N/A	Gutter Lip Ht (in)	N/A	N/A	Gutter	X Slope (%)	N/A
N/A	Painted X Walk1?	No	N/A	Painte	ed X Walk2?	No
	X Walk 1 Direction	To SW		X Wal	k 2 Direction	To SE
N/A	X Walk 1 Width (in)	N/A	N/A	X Wal	k 2 Width (in)	N/A
	X Walk 1 Slope (%)	1.8		X Wal	k 2 Slope (%)	0.3
	X Walk 1 X Slope (%)	1.1		X Wal	k 2 X Slope (%)	0.5

Remove & Replace Curb Ramp With Two New Directional Ramps or Equivalent.

> Total Cost: 3200.00
