Access Compliance Report

Public Rights-of-Way

(Curb Ramps)

Intersection ID: 30489	Main Street: BEDDINGFIELD_DR	Cross Street: STONES_LANDING_ST	Location: SE
ADA ID: 22D16BEBBB10	Ramp Type: PerpDiag	Initial Pass/Fail: Fail	Overall Compliance: No
Severity Score: 8.75			
Codes/Mitigation Info/Possible Solution		Field Measurements/Component Compliance

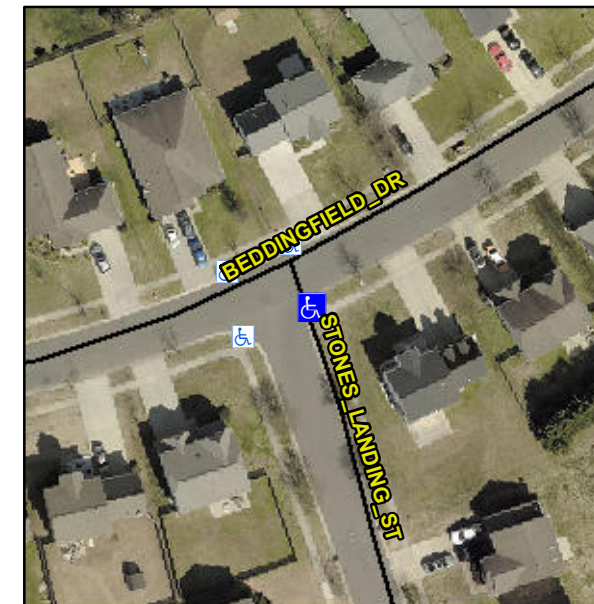
Not Found, R304.5.1

Compliance	Description	Data	Compliance	Description	Data
N/A	Ramp Length (in)	82.0	Yes	Ramp Slope (%)	5.0
No	Ramp Width (in)	47.0	Yes	Ramp XSlope (%)	0.8
N/A	Flare Type LT	N/A	N/A	Flare Type RT	N/A
N/A	Flare Slope LT (%)	N/A	N/A	Flare Slope RT (%)	N/A
N/A	Flare Traversable LT?	N/A	N/A	Flare Traversable RT?	N/A
N/A	Landing Length (in)	N/A	N/A	DWS Provided?	N/A
N/A	Landing Width (in)	N/A	N/A	DWS Contrast?	N/A
N/A	Landing Slope (%)	N/A	N/A	DWS Length (in)	N/A
N/A	Landing X Slope (%)	N/A	N/A	DWS Full Width?	N/A
N/A	Landing Curb? (Y/N)	N/A	N/A	DWS Offset (in)	N/A
N/A	Shared Landing?	N/A			
N/A	Gutter Ponding?	N/A	N/A	Gutter Slope (%)	N/A
N/A	Gutter Lip Ht (in)	N/A	N/A	Gutter X Slope (%)	N/A
N/A	Painted X Walk1?	No	N/A	Painted X Walk2?	No
	X Walk 1 Direction	To N		X Walk 2 Direction	To W
N/A	X Walk 1 Width (in)	N/A	N/A	X Walk 2 Width (in)	N/A
	X Walk 1 Slope (%)	4.5		X Walk 2 Slope (%)	1.9
	X Walk 1 X Slope (%)	2.5		X Walk 2 X Slope (%)	1.3

N/A	Ramp inside XWalk1?	N/A	N/A	Ramp inside XWalk2?	N/A
	Road Slope (%)	0.2	N/A	Clear Space?	N/A
	Road X Slope (%)	3.2	N/A	Clear Space to XWalk (in)	N/A
N/A	Any Obstructions?	N/A	N/A	Storm Grate/Utility Hazard?	N/A
	Obstruction Type			Storm Grate/Utility Type	
		N/A			N/A
		Yes		Surface Condition? (G/P)	Good

Remove & Replace Curb Ramp With Two New Directional Ramps or Equivalent.

Total Cost: \$ 3200.00
