Access Compliance Report Public Rights-of-Way (Curb Ramps)

Intersection ID: 27440 Main Street: BALLANTYNE_COMMONS_PY Cross Street: DOWINGTON_DR Location: NE

ADA ID: 22D4E0865DC1 Ramp Type: Perp Initial Pass/Fail: Fail **Overall Compliance: No Severity Score:** 8.75

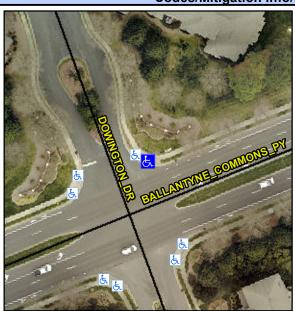
Field Measurements/Component Compliance								
Comp	liance Description	Data	Comp	liance	Description	Data		
N/A	Ramp Length (in)	107.0	Yes	Ramp	Slope (%)	5.4		
No	Ramp Width (in)	38.0	Yes	Ramp	XSlope (%)	1.2		
N/A	Flare Type LT	N/A	N/A	Flare	Type RT	N/A		
N/A	Flare Slope LT (%)	N/A	N/A	Flare	Slope RT (%)	N/A		
N/A	Flare Traversable LT?	N/A	N/A	Flare	Traversable RT?	N/A		
N/A	Landing Length (in)	N/A	N/A	DWS	Provided?	N/A		
N/A	Landing Width (in)	N/A	N/A	DWS	Contrast?	N/A		
N/A	Landing Slope (%)	N/A	N/A	DWS	Length (in)	N/A		
N/A	Landing X Slope (%)	N/A	N/A	DWS	Full Width?	N/A		
N/A	Landing Curb? (Y/N)	N/A	N/A	DWS	Offset (in)	N/A		
N/A	Shared Landing?	N/A						
N/A	Gutter Ponding?	N/A	N/A	Gutte	r Slope (%)	N/A		
N/A	Gutter Lip Ht (in)	N/A	N/A	Gutte	r X Slope (%)	N/A		
N/A	Painted X Walk1?	No	N/A	Painte	ed X Walk2?	N/A		
	X Walk 1 Direction	To SE		X Wal	k 2 Direction	N/A		
N/A	X Walk 1 Width (in)	N/A	N/A	X Wal	k 2 Width (in)	N/A

X Walk 1 Slope (%)	3.1		X Wal	k 2 Slope (%)	N/A		
	X Walk 1 X Slope (%)	0.1		X Wal	k 2 X Slope (%)	N/A		
N/A	Ramp inside XWalk1?	N/A	N/A	Ramp	inside XWalk2?	N/A		
	Road Slope (%)	N/A	N/A	Clear	Space?	N/A		
	Road X Slope (%)	N/A	N/A	Clear	Space to XWalk (in)	N/A		
N/A	Any Obstructions?	N/A	N/A	Storm	Grate/Utility Hazard?	N/A		
	Obstruction Type			Storm	Grate/Utility Type			
		N/A				N/A		
			Yes	Surfac	ce Condition? (G/P)	Good

1 033ibic odiation	
Possible Solutions:	Cor
Remove & Replace Entire Ramp.	N/A
	No
	N/A
	N/A
	N/A
	N/A
Surveyor Notes:	N/A
N/A	N/A
	N/A
	N/A
	N/A
PROW/ADA:	N/A
Not Found, R304.5.1	N/A
	N/A
	N/A
	N/A
