Access Compliance Report

Public Rights-of-Way

(Curb Ramps)

| Intersection ID: 53421 | Main Street: ARDREY_KELL_RD | Cross Street: N/A | Location: NW |

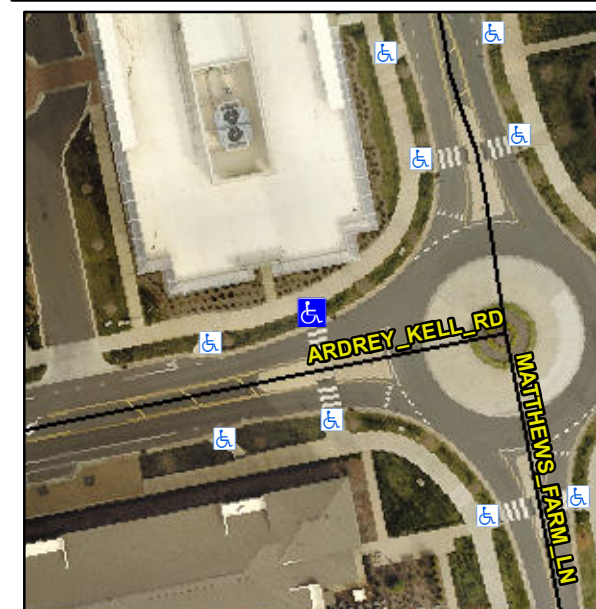
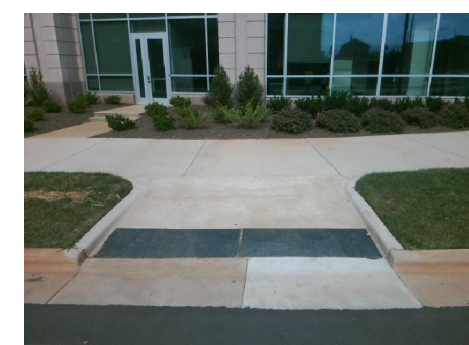
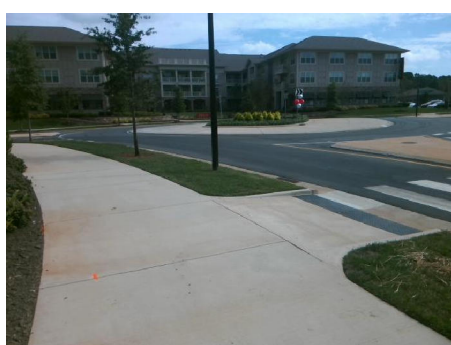
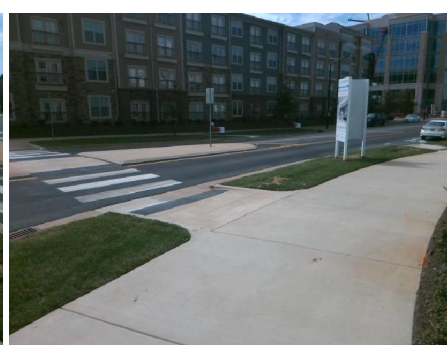
| ADA ID: 22DD3E286CC5 | Ramp Type: Perp | Initial Pass/Fail: Fail | Overall Compliance: No |
| Severity Score: 12.5 | | | |

Not Found, R304.2.2

| Compliance | Description | Data | Compliance | Description | Data |
|---|---|---|---|---|---|
| N/A | Ramp Length (in) | 96.0 | No | Ramp Slope (%) | 8.6 |

Remove & Replace Entire Ramp.
