Access Compliance Report

Public Rights-of-Way

(Curb Ramps)

Intersection ID: 47847	Main Street: ALVARADO_WY	Cross Street: CACTUS_VALLEY_RD	Location: NE
ADA ID: 22DDDA83C850	Ramp Type: Perp	Initial Pass/Fail: Fail	Overall Compliance: No
Severity Score: 21.25			
Codes/Mitigation Info/Possible Solution		Field Measurements/Component Compliance

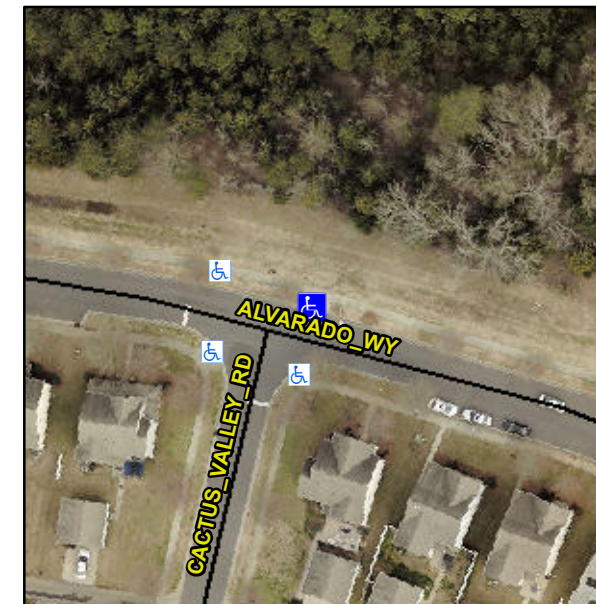
Not Found, R304.5.1, R304.2.2

Compliance	Description	Data	Compliance	Description	Data
N/A	Ramp Length (in)	74.0	No	Ramp Slope (%)	11.0
No	Ramp Width (in)	46.5	Yes	Ramp XSlope (%)	0.5
N/A	Flare Type LT	N/A	N/A	Flare Type RT	N/A
N/A	Flare Slope LT (%)	N/A	N/A	Flare Slope RT (%)	N/A
N/A	Flare Traversable LT?	N/A	N/A	Flare Traversable RT?	N/A
N/A	Landing Length (in)	N/A	N/A	DWS Provided?	N/A
N/A	Landing Width (in)	N/A	N/A	DWS Contrast?	N/A
N/A	Landing Slope (%)	N/A	N/A	DWS Length (in)	N/A
N/A	Landing X Slope (%)	N/A	N/A	DWS Full Width?	N/A
N/A	Landing Curb? (Y/N)	N/A	N/A	DWS Offset (in)	N/A
N/A	Shared Landing?	N/A			
N/A	Gutter Ponding?	N/A	N/A	Gutter Slope (%)	N/A
N/A	Gutter Lip Ht (in)	N/A	N/A	Gutter X Slope (%)	N/A
N/A	Painted X Walk1?	No	N/A	Painted X Walk2?	N/A
	X Walk 1 Direction	To SW		X Walk 2 Direction	N/A
N/A	X Walk 1 Width (in)	N/A	N/A	X Walk 2 Width (in)	N/A
	X Walk 1 Slope (%)	1.9		X Walk 2 Slope (%)	N/A
	X Walk 1 X Slope (%)	0.9		X Walk 2 X Slope (%)	N/A

N/A	Ramp inside XWalk1?	N/A	N/A	Ramp inside XWalk2?	N/A
	Road Slope (%)	N/A	N/A	Clear Space?	N/A
	Road X Slope (%)	N/A	N/A	Clear Space to XWalk (in)	N/A
N/A	Any Obstructions?	N/A	N/A	Storm Grate/Utility Hazard?	N/A
	Obstruction Type			Storm Grate/Utility Type	
		N/A			N/A
		Yes		Surface Condition? (G/P)	Good

Possible Solutions:

Remove & Replace Entire Ramp.
