# Access Compliance Report

## Public Rights-of-Way

### (Curb Ramps)

| Intersection ID: N/A | Main Street: BRADSTREET COMMONS WY | Cross Street: ROTHMAN LN | Location: SE |

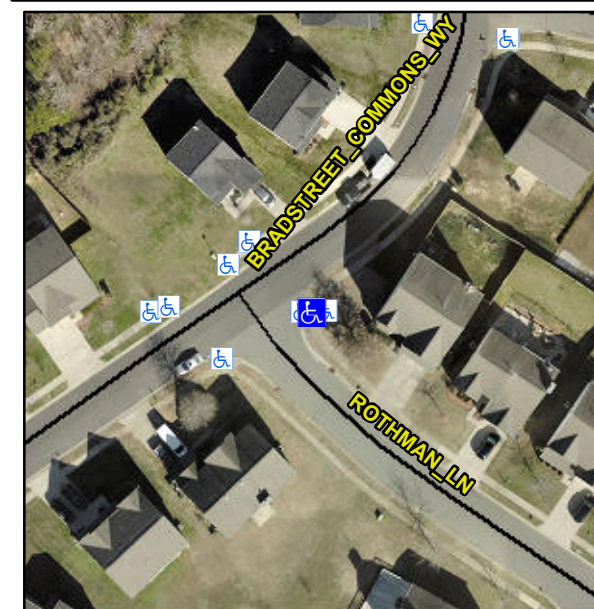
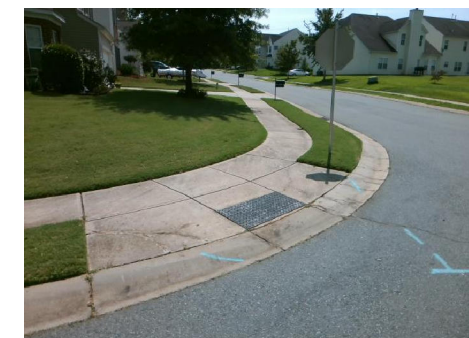
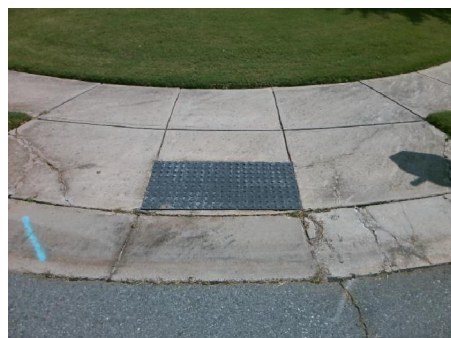
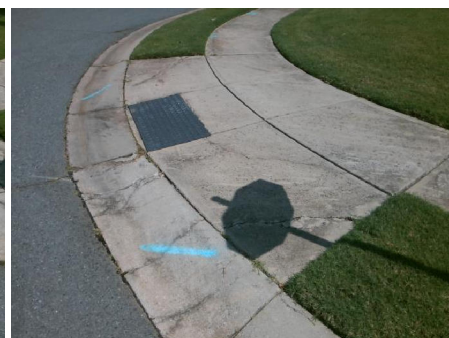
**Not Found, R304.5.1, R304.5.1, R304.2.2, R304.5.3**

| Compliance | Description | Data | Compliance | Description | Data |
|---|---|---|---|---|---|
| No | Ramp Width LT (in) | 47.0 | No | Ramp Width RT (in) | 47.0 |
| Yes | Ramp XSlope LT (%) | 1.8 | No | Ramp XSlope RT (%) | 2.6 |
| N/A | Ramp Length (in) | 48.5 | No | Ramp Slope (%) | 11.0 |
| No | Ramp Width (in) | 46.5 | No | Ramp XSlope (%) | 2.4 |

**Remove & Replace Curb Ramp With Two New Directional Ramps or Equivalent.**
