Access Compliance Report Public Rights-of-Way (Curb Ramps)

Intersection ID: 13743Main Street:DR_CARVER_RDCross Street: WEST_BVLocation:NEADA ID: 22E7B870033CRamp Type:PerpInitial Pass/Fail:FailOverall Compliance: NoSeverity Score:37.5

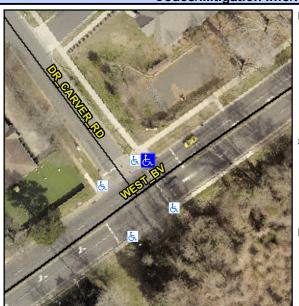
Field Measurements/Component Compliance						
Comp	liance Description	Data	Comp	liance Description	Data	
N/A	Ramp Length (in)	144.0	No	Ramp Slope (%)	8.6	
Yes	Ramp Width (in)	48.0	No	Ramp XSlope (%)	10.3	
N/A	Flare Type LT	N/A	N/A	Flare Type RT	N/A	
N/A	Flare Slope LT (%)	N/A	N/A	Flare Slope RT (%)	N/A	
N/A	Flare Traversable LT?	N/A	N/A	Flare Traversable RT?	N/A	
N/A	Landing Length (in)	N/A	N/A	DWS Provided?	N/A	
N/A	Landing Width (in)	N/A	N/A	DWS Contrast?	N/A	
N/A	Landing Slope (%)	N/A	N/A	DWS Length (in)	N/A	
N/A	Landing X Slope (%)	N/A	N/A	DWS Full Width?	N/A	
N/A	Landing Curb? (Y/N)	N/A	N/A	DWS Offset (in)	N/A	
N/A	Shared Landing?	N/A				
N/A	Gutter Ponding?	N/A	N/A	Gutter Slope (%)	N/A	
N/A	Gutter Lip Ht (in)	N/A	N/A	Gutter X Slope (%)	N/A	
N/A	Painted X Walk1?	Yes	N/A	Painted X Walk2?	N/A	
	X Walk 1 Direction	To SE		X Walk 2 Direction	N/A	
N/A	X Walk 1 Width (in)	108.0	N/A	X Walk 2 Width (in)	N/A	
	X Walk 1 Slope (%)	2.0		X Walk 2 Slope (%)	N/A

X Walk 1 X Slope (%)	2.4		X Walk 2 X Slope (%)	N/A	
N/A	Ramp inside XWalk1?	Yes	N/A	Ramp inside XWalk2?	N/A	
	Road Slope (%)	N/A	N/A	Clear Space?	N/A	
	Road X Slope (%)	N/A	N/A	Clear Space to XWalk (in)	N/A	
N/A	Any Obstructions?	N/A	N/A	Storm Grate/Utility Hazard?	N/A	
	Obstruction Type			Storm Grate/Utility Type		
		N/A			N/A	
			Yes	Surface Condition? (G/P)	Good

Possible Solutions:	9
Remove & Replace Entire Ramp.	N
	Y
	N
	N
	N
	N
Surveyor Notes:	N
N/A	N
	N
	N
	N
PROW/ADA:	N
Not Found, R304.2.2, R304.5.3	N
	N
	N
