Access Compliance Report

Public Rights-of-Way

(Curb Ramps)

Intersection ID: 3147	Main Street: BROWNESTONE_VIEW_DR	Cross Street: MINERAL_RIDGE_WY	Location: N
ADA ID: 22E98C903A70	Ramp Type: Perp	Initial Pass/Fail: Fail	Overall Compliance: No
Severity Score: 36.25			
Codes/Mitigation Info/Possible Solution		Field Measurements/Component Compliance

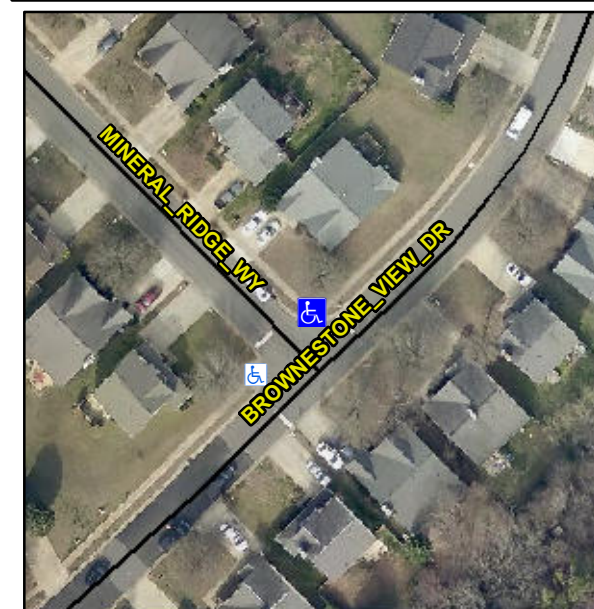
Not Found, R304.5.1, R304.5.3

Compliance	Description	Data	Compliance	Description	Data
N/A	Ramp Length (in)	94.0	Yes	Ramp Slope (%)	5.0
No	Ramp Width (in)	30.0	No	Ramp XSlope (%)	3.1
N/A	Flare Type LT	N/A	N/A	Flare Type RT	N/A
N/A	Flare Slope LT (%)	N/A	N/A	Flare Slope RT (%)	N/A
N/A	Flare Traversable LT?	N/A	N/A	Flare Traversable RT?	N/A
N/A	Landing Length (in)	N/A	N/A	DWS Provided?	N/A
N/A	Landing Width (in)	N/A	N/A	DWS Contrast?	N/A
N/A	Landing Slope (%)	N/A	N/A	DWS Length (in)	N/A
N/A	Landing X Slope (%)	N/A	N/A	DWS Full Width?	N/A
N/A	Landing Curb? (Y/N)	N/A	N/A	DWS Offset (in)	N/A
N/A	Shared Landing?	N/A			
N/A	Gutter Ponding?	N/A	N/A	Gutter Slope (%)	N/A
N/A	Gutter Lip Ht (in)	N/A	N/A	Gutter X Slope (%)	N/A
N/A	Painted X Walk1?	No	N/A	Painted X Walk2?	N/A
	X Walk 1 Direction	To SW		X Walk 2 Direction	N/A
N/A	X Walk 1 Width (in)	N/A	N/A	X Walk 2 Width (in)	N/A
	X Walk 1 Slope (%)	4.9		X Walk 2 Slope (%)	N/A
	X Walk 1 X Slope (%)	6.4		X Walk 2 X Slope (%)	N/A

N/A	Ramp inside XWalk1?	N/A	N/A	Ramp inside XWalk2?	N/A
	Road Slope (%)	N/A	N/A	Clear Space?	N/A
	Road X Slope (%)	N/A	N/A	Clear Space to XWalk (in)	N/A
N/A	Any Obstructions?	N/A	N/A	Storm Grate/Utility Hazard?	N/A
	Obstruction Type			Storm Grate/Utility Type	
		N/A			N/A
			Yes	Surface Condition? (G/P)	Good

Possible Solutions:

Remove & Replace Entire Ramp.

Total Cost: \$ 1850.00
