# Access Compliance Report

## Public Rights-of-Way

### (Curb Ramps)

Intersection ID: 45629	Main Street: SARDIS_RD_NORTH	Cross Street: GALLERIA_BV	Location: NW
ADA ID: 22EE80FABBC7	Ramp Type: Perp	Initial Pass/Fail: Fail	Overall Compliance: No
Severity Score: 37.5			
Codes/Mitigation Info/Possible Solution		Field Measurements/Component Compliance

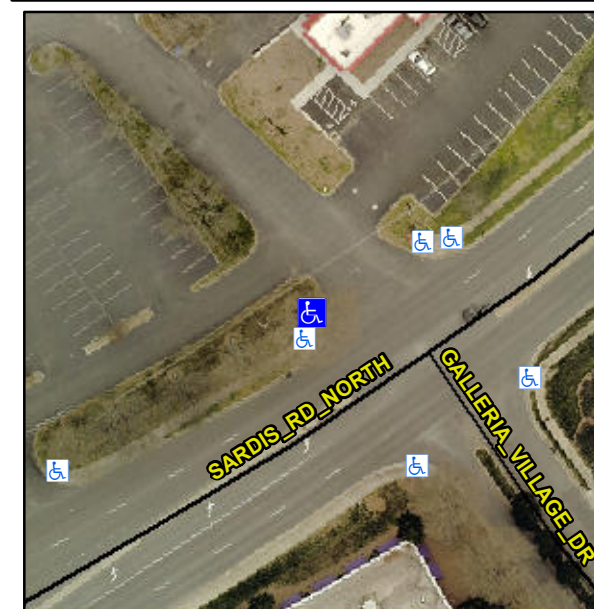
**Not Found, R304.5.1, R304.2.2, R304.5.3, R302.7**

Compliance	Description	Data	Compliance	Description	Data
N/A	Ramp Length (in)	72.0	No	Ramp Slope (%)	9.1
No	Ramp Width (in)	47.0	No	Ramp XSlope (%)	2.7
N/A	Flare Type LT	N/A	N/A	Flare Type RT	N/A
N/A	Flare Slope LT (%)	N/A	N/A	Flare Slope RT (%)	N/A
N/A	Flare Traversable LT?	N/A	N/A	Flare Traversable RT?	N/A
N/A	Landing Length (in)	N/A	N/A	DWS Provided?	N/A
N/A	Landing Width (in)	N/A	N/A	DWS Contrast?	N/A
N/A	Landing Slope (%)	N/A	N/A	DWS Length (in)	N/A
N/A	Landing X Slope (%)	N/A	N/A	DWS Full Width?	N/A
N/A	Landing Curb? (Y/N)	N/A	N/A	DWS Offset (in)	N/A
N/A	Shared Landing?	N/A			
N/A	Gutter Ponding?	N/A	N/A	Gutter Slope (%)	N/A
N/A	Gutter Lip Ht (in)	N/A	N/A	Gutter X Slope (%)	N/A
N/A	Painted X Walk1?	No	N/A	Painted X Walk2?	N/A
	X Walk 1 Direction	To NE		X Walk 2 Direction	N/A
N/A	X Walk 1 Width (in)	N/A	N/A	X Walk 2 Width (in)	N/A
	X Walk 1 Slope (%)	0.8		X Walk 2 Slope (%)	N/A
	X Walk 1 X Slope (%)	2.7		X Walk 2 X Slope (%)	N/A

N/A	Ramp inside XWalk1?	N/A	N/A	Ramp inside XWalk2?	N/A
	Road Slope (%)	N/A	N/A	Clear Space?	N/A
	Road X Slope (%)	N/A	N/A	Clear Space to XWalk (in)	N/A
N/A	Any Obstructions?	N/A	N/A	Storm Grate/Utility Hazard?	N/A
	Obstruction Type			Storm Grate/Utility Type	
		N/A			N/A
		No		Surface Condition? (G/P)	Poor

**Remove & Replace Entire Ramp.**

Total Cost: \$ 1850.00
