Access Compliance Report Public Rights-of-Way (Curb Ramps)

Intersection ID: 49389 Main Street: AUBRAC_LN Cross Street: SHORTHORN_ST Location: NE

ADA ID: 22FD22E4B0CC Ramp Type: Perp Initial Pass/Fail: Fail Overall Compliance: No Severity Score: 8.75

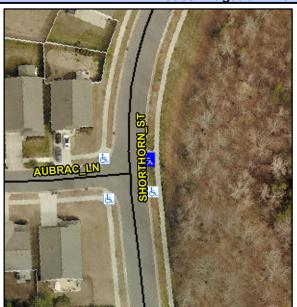
Compl	iance Description	Data	Compl	iance	Description	Data
N/A	Ramp Length (in)	95.0	Yes	Ramp	Slope (%)	7.5
No	Ramp Width (in)	47.0	Yes	Ramp	xSlope (%)	1.2
N/A	Flare Type LT	N/A	N/A	Flare	Type RT	N/A
N/A	Flare Slope LT (%)	N/A	N/A	Flare	Slope RT (%)	N/A
N/A	Flare Traversable LT?	N/A	N/A	Flare	Traversable RT?	N/A
N/A	Landing Length (in)	N/A	N/A	DWS	Provided?	N/A
N/A	Landing Width (in)	N/A	N/A	DWS	Contrast?	N/A
N/A	Landing Slope (%)	N/A	N/A	DWS	Length (in)	N/A
N/A	Landing X Slope (%)	N/A	N/A	DWS	Full Width?	N/A
N/A	Landing Curb? (Y/N)	N/A	N/A	DWS	Offset (in)	N/A
N/A	Shared Landing?	N/A				
N/A	Gutter Ponding?	N/A	N/A	Gutte	er Slope (%)	N/A
N/A	Gutter Lip Ht (in)	0.5	N/A	Gutte	er X Slope (%)	N/A
N/A	Painted X Walk1?	No	N/A	Paint	ed X Walk2?	N/A
	X Walk 1 Direction	To W		X Wa	lk 2 Direction	N/A
N/A	X Walk 1 Width (in)	N/A	N/A	X Wa	ılk 2 Width (in)	N/A
	X Walk 1 Slope (%)	3.2		X Wa	ılk 2 Slope (%)	N/A
	X Walk 1 X Slope (%)	1.3		X Wa	ılk 2 X Slope (%)	N/A

N/A	Ramp inside XWalk1?	N/A	N/A	Ram	p inside XWalk2?	N/A
	Road Slope (%)	N/A	N/A	Clear	Space?	N/A
	Road X Slope (%)	N/A	N/A	Clear	Space to XWalk (in)	N/A
N/A	Any Obstructions?	N/A	N/A	Storn	n Grate/Utility Hazard?	N/A
	Obstruction Type			Storn	n Grate/Utility Type	
		N/A				N/A
			Yes	Surfa	ice Condition? (G/P)	Good

1 CCCIDIC CCIALICIT	
Possible Solutions:	Con
Remove & Replace Entire Ramp.	N/A
	No
	N/A
	N/A
	N/A
	N/A
Surveyor Notes:	N/A
N/A	N/A
	N/A
	N/A
	N/A
PROW/ADA:	N/A
Not Found, R304.5.1	N/A
•	N/A
	N/A
	N/A
