Access Compliance Report

Public Rights-of-Way

(Curb Ramps)

Intersection ID: 21410	Main Street: LANDMARK_DR	Cross Street: SARDIS_LN	Location: S
ADA ID: 230117FD81FB	Ramp Type: Directional1	Initial Pass/Fail: Fail	Overall Compliance: No
		Severity Score: 1.25

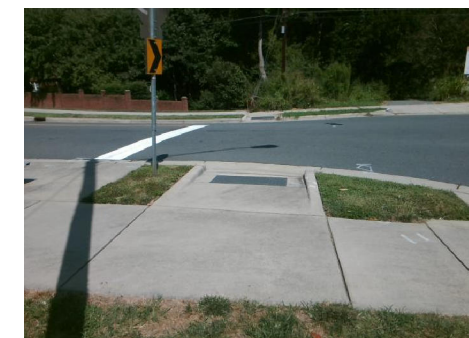
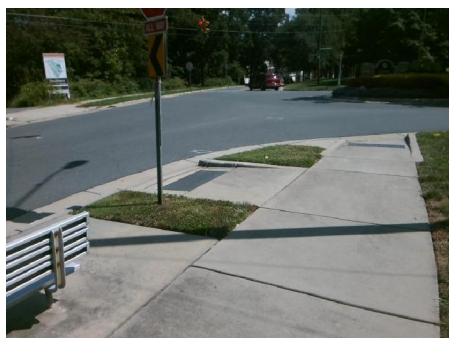
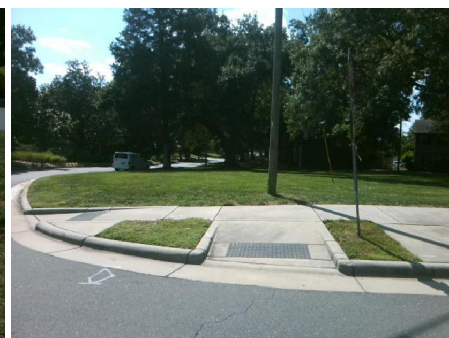
R304.5.3

Compliance	Description	Data	Compliance	Description	Data
N/A	Ramp Length (in)	75.0	N/A	Grade Break?	N/A
Yes	Ramp Width (in)	71.0	N/A	Grade Break Slope (%)	0.0
Yes	Ramp Slope (%)	7.8	N/A	Grade Break XSlope (%)	0.0
No	Ramp XSlope (%)	3.5			
N/A	Flare Type LT	N/A	N/A	Flare Type RT	N/A
N/A	Flare Slope LT (%)	N/A	N/A	Flare Slope RT (%)	0.0
N/A	Flare Traversable LT?	N/A	N/A	Flare Traversable RT?	N/A
N/A	Landing Length (in)	0.0	N/A	DWS Provided?	N/A
N/A	Landing Width (in)	0.0	N/A	DWS Contrast?	N/A
N/A	Landing Slope (%)	0.0	N/A	DWS Length (in)	N/A
N/A	Landing X Slope (%)	0.0	N/A	DWS Full Width?	N/A
N/A	Landing Curb? (Y/N)	N/A	N/A	DWS Offset LT (in)	N/A
N/A	Shared Landing?	N/A	N/A	DWS Offset RT (in)	N/A
N/A	Gutter Ponding?	0.0	N/A	Gutter Slope (%)	N/A
N/A	Gutter Lip Ht (in)	0.0	N/A	Gutter X Slope (%)	N/A
N/A	Painted X Walk1?	No		Road Slope (%)	0.2
	X Walk 1 Direction	To NW		Road X Slope (%)	1.5
	X Walk 1 Width (in)	N/A		Clear Space?	N/A

X Walk 1 Slope (%)	0.2	N/A	Clear Space to XWalk (in)	N/A
	X Walk 1 X Slope (%)	1.5	N/A	Storm Grate/Utility Hazard?	N/A
N/A	Ramp inside XWalk1?	N/A		Storm Grate/Utility Type	
N/A	Any Obstructions?	N/A			N/A
	Obstruction Type		Yes	Surface Condition? (G/P)	Good
			N/A	Curb Slope (%)	0.2

Remove & Replace Entire Ramp.
