Access Compliance Report Public Rights-of-Way (Curb Ramps)

Intersection ID: 44001 Main Street: ELROSE_PL Cross Street: N/A Location: NW

ADA ID: 2302CDF2532C Ramp Type: Perp Initial Pass/Fail: Fail Overall Compliance: No Severity Score: 46.25

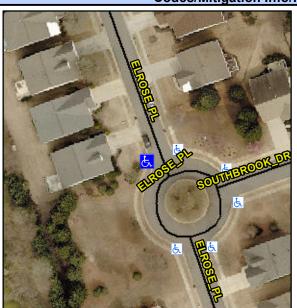
Field Measurements/Component Compliance						
Comp	liance Description	Data	Comp	liance	Description	Data
N/A	Ramp Length (in)	48.0	No	Ramp	Slope (%)	12.5
No	Ramp Width (in)	46.0	No	Ramp	XSlope (%)	5.4
N/A	Flare Type LT	N/A	N/A	Flare	Type RT	N/A
N/A	Flare Slope LT (%)	N/A	N/A	Flare	Slope RT (%)	N/A
N/A	Flare Traversable LT?	N/A	N/A	Flare	Traversable RT?	N/A
N/A	Landing Length (in)	N/A	N/A	DWS	Provided?	N/A
N/A	Landing Width (in)	N/A	N/A	DWS	Contrast?	N/A
N/A	Landing Slope (%)	N/A	N/A	DWS	Length (in)	N/A
N/A	Landing X Slope (%)	N/A	N/A	DWS	Full Width?	N/A
N/A	Landing Curb? (Y/N)	N/A	N/A	DWS	Offset (in)	N/A
N/A	Shared Landing?	N/A				
N/A	Gutter Ponding?	N/A	N/A	Gutte	r Slope (%)	N/A
N/A	Gutter Lip Ht (in)	N/A	N/A	Gutte	r X Slope (%)	N/A
N/A	Painted X Walk1?	No	N/A	Paint	ed X Walk2?	N/A
	X Walk 1 Direction	To E		X Wa	lk 2 Direction	N/A
N/A	X Walk 1 Width (in)	N/A	N/A	X Wa	lk 2 Width (in)	N/A
	X Walk 1 Slope (%)	2.5		X Wa	lk 2 Slope (%)	N/A

X Walk 1 X Slope (%)	3.9		X Wa	lk 2 X Slope (%)	N/A
N/A	Ramp inside XWalk1?	N/A	N/A	Ram	inside XWalk2?	N/A
	Road Slope (%)	N/A	N/A	Clear	Space?	N/A
	Road X Slope (%)	N/A	N/A	Clear	Space to XWalk (in)	N/A
N/A	Any Obstructions?	N/A	N/A	Storn	n Grate/Utility Hazard?	N/A
	Obstruction Type			Storn	n Grate/Utility Type	
		N/A				N/A
			Yes	Surfa	ce Condition? (G/P)	Good

Possible Solutions:				
Remove & Replace Entire Ramp.				
Surveyor Notes:				
N/A				
PROW/ADA:				
Not Found, R304.5.1, R304.2.2, R304.5.3				
1004.0.0				
I

Total Cost:	\$ 1850.00
