Intersection ID: 26070	Main Street: BLUE_HERON_DR	Cross Street: PARK_VISTA_CR	Location:	NW
ADA ID: 23037FC00CCB	Ramp Type: Directional1	Initial Pass/Fail: Fail	Overall Compliance: No	Severity Score: 26.25

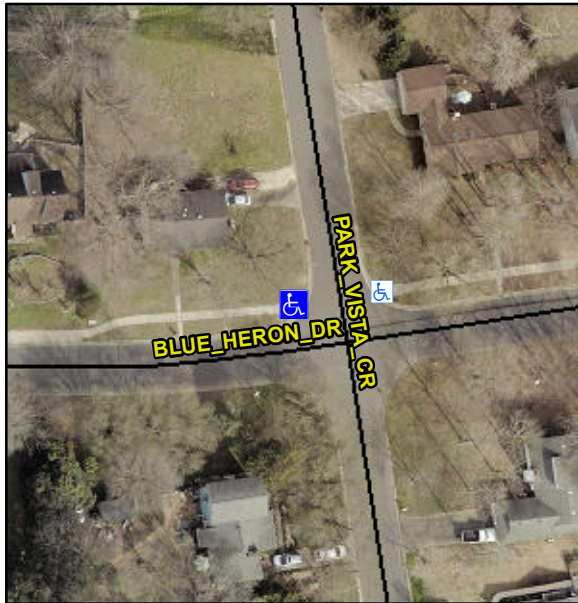
R304.2.2, R304.5.3

Compliance	Description	Data	Compliance	Description	Data
N/A	Ramp Length (in)	134.0	N/A	Grade Break?	N/A
Yes	Ramp Width (in)	59.0	N/A	Grade Break Slope (%)	0.0
No	Ramp Slope (%)	13.6	N/A	Grade Break XSlope (%)	0.0
No	Ramp XSlope (%)	2.1			
N/A	Flare Type LT	N/A	N/A	Flare Type RT	N/A
N/A	Flare Slope LT (%)	N/A	N/A	Flare Slope RT (%)	0.0
N/A	Flare Traversable LT?	N/A	N/A	Flare Traversable RT?	N/A
N/A	Landing Length (in)	0.0	N/A	DWS Provided?	N/A
N/A	Landing Width (in)	0.0	N/A	DWS Contrast?	N/A
N/A	Landing Slope (%)	0.0	N/A	DWS Length (in)	N/A
N/A	Landing X Slope (%)	0.0	N/A	DWS Full Width?	N/A
N/A	Landing Curb? (Y/N)	N/A	N/A	DWS Offset LT (in)	N/A
N/A	Shared Landing?	N/A	N/A	DWS Offset RT (in)	N/A
N/A	Gutter Ponding?	0.0	N/A	Gutter Slope (%)	N/A
N/A	Gutter Lip Ht (in)	0.0	N/A	Gutter X Slope (%)	N/A
N/A	Painted X Walk1?	No		Road Slope (%)	2.5
	X Walk 1 Direction	To NE		Road X Slope (%)	7.2
	X Walk 1 Width (in)	N/A		Clear Space?	N/A

X Walk 1 Slope (%)	2.5	N/A	Clear Space to XWalk (in)	N/A
	X Walk 1 X Slope (%)	7.2	N/A	Storm Grate/Utility Hazard?	N/A
N/A	Ramp inside XWalk1?	N/A		Storm Grate/Utility Type	
N/A	Any Obstructions?	N/A			N/A
	Obstruction Type		Yes	Surface Condition? (G/P)	Good
		N/A	N/A	Curb Slope (%)	0.7

Remove & Replace Entire Ramp.

Total Cost: \$ 1600.00

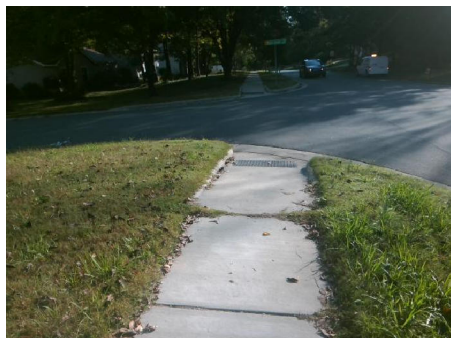
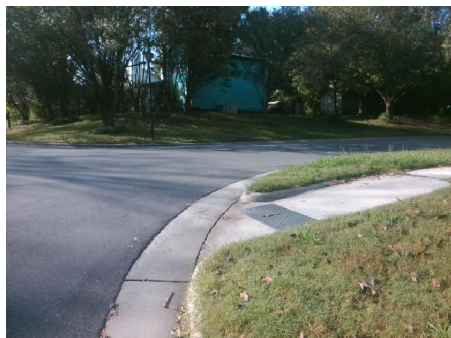
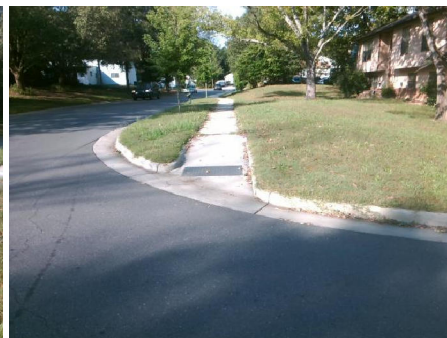
Street 1 Name	PARK VISTA CR
Stop Condition-Street 1	StopSign
Street 2 Name	N/A
Stop Condition-Street 2	N/A
