# Access Compliance Report

## Public Rights-of-Way

### (Curb Ramps)

| Intersection ID: 17352 | Main Street: BRANTHAM_CT | Cross Street: WALKER_RD | Location: NW |

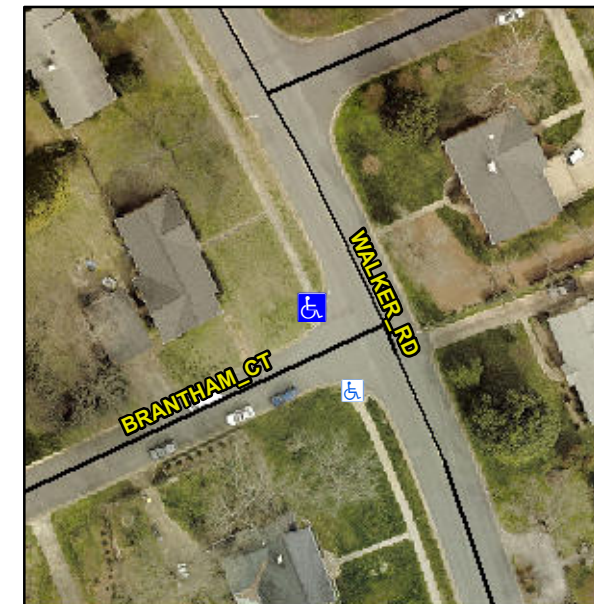
| ADA ID: 2304B884726E | Ramp Type: PerpDiag | Initial Pass/Fail: Fail | Overall Compliance: No |

**Not Found, R304.5.1, R304.2.2**

| Compliance | Description | Data | Compliance | Description | Data |
|---|---|---|---|---|---|
| N/A | Ramp Length (in) | 48.5 | No | Ramp Slope (%) | 8.7 |
| No | Ramp Width (in) | 42.0 | Yes | Ramp XSlope (%) | 1.2 |

**Remove & Replace Curb Ramp With Two New Directional Ramps or Equivalent.**
