Access Compliance Report

Public Rights-of-Way

(Curb Ramps)

Intersection ID: 23363	Main Street: CARNOUSTIE_LN	Cross Street: QUAIL_HOLLOW_RD	Location: W
ADA ID: 2310C74D8F1B	Ramp Type: PerpDiag	Initial Pass/Fail: Fail	Overall Compliance: No
Severity Score: 12.5			
Codes/Mitigation Info/Possible Solution		Field Measurements/Component Compliance

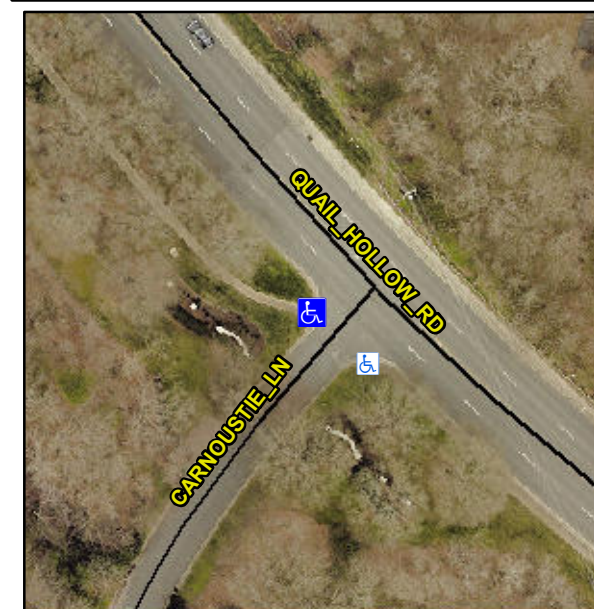
Not Found, R304.5.3

Compliance	Description	Data	Compliance	Description	Data
N/A	Ramp Length (in)	57.0	Yes	Ramp Slope (%)	5.3
Yes	Ramp Width (in)	48.0	No	Ramp XSlope (%)	6.5
N/A	Flare Type LT	N/A	N/A	Flare Type RT	N/A
N/A	Flare Slope LT (%)	N/A	N/A	Flare Slope RT (%)	N/A
N/A	Flare Traversable LT?	N/A	N/A	Flare Traversable RT?	N/A
N/A	Landing Length (in)	N/A	N/A	DWS Provided?	N/A
N/A	Landing Width (in)	N/A	N/A	DWS Contrast?	N/A
N/A	Landing Slope (%)	N/A	N/A	DWS Length (in)	N/A
N/A	Landing X Slope (%)	N/A	N/A	DWS Full Width?	N/A
N/A	Landing Curb? (Y/N)	N/A	N/A	DWS Offset (in)	N/A
N/A	Shared Landing?	N/A			
N/A	Gutter Ponding?	N/A	N/A	Gutter Slope (%)	N/A
N/A	Gutter Lip Ht (in)	N/A	N/A	Gutter X Slope (%)	N/A
N/A	Painted X Walk1?	No	N/A	Painted X Walk2?	No
	X Walk 1 Direction	To SE		X Walk 2 Direction	To NE
N/A	X Walk 1 Width (in)	N/A	N/A	X Walk 2 Width (in)	N/A
	X Walk 1 Slope (%)	0.8		X Walk 2 Slope (%)	7.0
	X Walk 1 X Slope (%)	6.5		X Walk 2 X Slope (%)	0.4

N/A	Ramp inside XWalk1?	N/A	N/A	Ramp inside XWalk2?	N/A
	Road Slope (%)	8.0	N/A	Clear Space?	N/A
	Road X Slope (%)	2.5	N/A	Clear Space to XWalk (in)	N/A
N/A	Any Obstructions?	N/A	N/A	Storm Grate/Utility Hazard?	N/A
	Obstruction Type			Storm Grate/Utility Type	
		N/A			N/A
			Yes	Surface Condition? (G/P)	Good

Remove & Replace Curb Ramp With Two New Directional Ramps or Equivalent.
