Access Compliance Report

Public Rights-of-Way

(Curb Ramps)

Intersection ID: 8512	Main Street: ISENHOUR_ST	Cross Street: MCARTHUR_AV	Location: SE
ADA ID: 2314ABF2A2AF	Ramp Type: PerpDiag	Initial Pass/Fail: Fail	Overall Compliance: No
Severity Score: 33.75			
Codes/Mitigation Info/Possible Solution		Field Measurements/Component Compliance

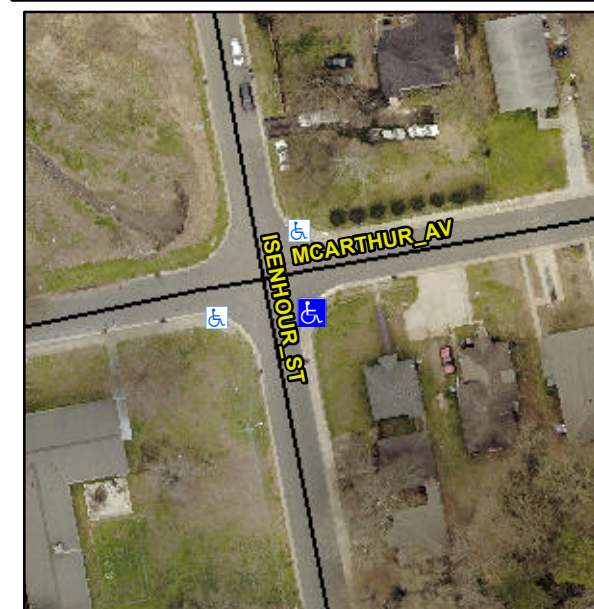
PROW/ADA:

Not Found, R304.5.1, R304.2.2

Compliance	Description	Data	Compliance	Description	Data
N/A	Ramp Length (in)	51.0	No	Ramp Slope (%)	13.7
No	Ramp Width (in)	40.0	Yes	Ramp XSlope (%)	1.3
N/A	Flare Type LT	N/A	N/A	Flare Type RT	N/A
N/A	Flare Slope LT (%)	N/A	N/A	Flare Slope RT (%)	N/A
N/A	Flare Traversable LT?	N/A	N/A	Flare Traversable RT?	N/A
N/A	Landing Length (in)	N/A	N/A	DWS Provided?	N/A
N/A	Landing Width (in)	N/A	N/A	DWS Contrast?	N/A
N/A	Landing Slope (%)	N/A	N/A	DWS Length (in)	N/A
N/A	Landing X Slope (%)	N/A	N/A	DWS Full Width?	N/A
N/A	Landing Curb? (Y/N)	N/A	N/A	DWS Offset (in)	N/A
N/A	Shared Landing?	N/A			
N/A	Gutter Ponding?	N/A	N/A	Gutter Slope (%)	N/A
N/A	Gutter Lip Ht (in)	N/A	N/A	Gutter X Slope (%)	N/A
N/A	Painted X Walk1?	No	N/A	Painted X Walk2?	No
	X Walk 1 Direction	To N		X Walk 2 Direction	To W
N/A	X Walk 1 Width (in)	N/A	N/A	X Walk 2 Width (in)	N/A
	X Walk 1 Slope (%)	0.7		X Walk 2 Slope (%)	1.7
	X Walk 1 X Slope (%)	3.4		X Walk 2 X Slope (%)	1.5

N/A	Ramp inside XWalk1?	N/A	N/A	Ramp inside XWalk2?	N/A
	Road Slope (%)	1.8	N/A	Clear Space?	N/A
	Road X Slope (%)	1.9	N/A	Clear Space to XWalk (in)	N/A
N/A	Any Obstructions?	N/A	N/A	Storm Grate/Utility Hazard?	N/A
	Obstruction Type			Storm Grate/Utility Type	
		N/A			N/A
			Yes	Surface Condition? (G/P)	Good

Possible Solutions:

Remove & Replace Curb Ramp With Two New Directional Ramps or Equivalent.

Total Cost: \$ 3200.00
