Access Compliance Report

Public Rights-of-Way

(Curb Ramps)

Intersection ID: 53088	Main Street: KENMERE_LN	Cross Street: DEERFIELD_MANOR_DR	Location: NE
ADA ID: 2328DBDDE11C	Ramp Type: Perp	Initial Pass/Fail: Fail	Overall Compliance: No
Severity Score: 25			
Codes/Mitigation Info/Possible Solution		Field Measurements/Component Compliance

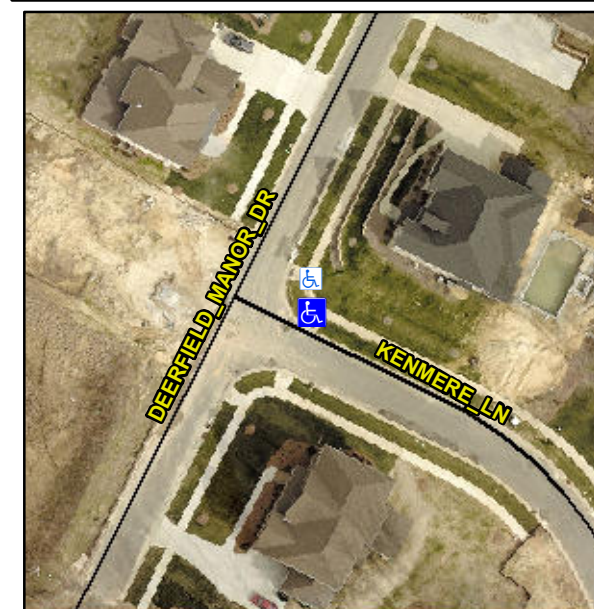
Compliance	Description	Data	Compliance	Description	Data
N/A	Ramp Length (in)	106.0	No	Ramp Slope (%)	13.4
Yes	Ramp Width (in)	48.0	Yes	Ramp XSlope (%)	0.5
N/A	Flare Type LT	N/A	N/A	Flare Type RT	N/A
N/A	Flare Slope LT (%)	N/A	N/A	Flare Slope RT (%)	N/A
N/A	Flare Traversable LT?	N/A	N/A	Flare Traversable RT?	N/A
N/A	Landing Length (in)	N/A	N/A	DWS Provided?	N/A
N/A	Landing Width (in)	N/A	N/A	DWS Contrast?	N/A
N/A	Landing Slope (%)	N/A	N/A	DWS Length (in)	N/A
N/A	Landing X Slope (%)	N/A	N/A	DWS Full Width?	N/A
N/A	Landing Curb? (Y/N)	N/A	N/A	DWS Offset (in)	N/A
N/A	Shared Landing?	N/A			
N/A	Gutter Ponding?	N/A	N/A	Gutter Slope (%)	N/A
N/A	Gutter Lip Ht (in)	N/A	N/A	Gutter X Slope (%)	N/A
N/A	Painted X Walk1?	No	N/A	Painted X Walk2?	N/A
	X Walk 1 Direction	To SW		X Walk 2 Direction	N/A
N/A	X Walk 1 Width (in)	N/A	N/A	X Walk 2 Width (in)	N/A
	X Walk 1 Slope (%)	2.3		X Walk 2 Slope (%)	N/A
	X Walk 1 X Slope (%)	3.0		X Walk 2 X Slope (%)	N/A

N/A	Ramp inside XWalk1?	N/A	N/A	Ramp inside XWalk2?	N/A
	Road Slope (%)	N/A	N/A	Clear Space?	N/A
	Road X Slope (%)	N/A	N/A	Clear Space to XWalk (in)	N/A
N/A	Any Obstructions?	N/A	N/A	Storm Grate/Utility Hazard?	N/A
	Obstruction Type			Storm Grate/Utility Type	
		N/A			N/A
			Yes	Surface Condition? (G/P)	Good

Possible Solutions:

Remove & Replace Entire Ramp.

PROW/ADA:

R304.2.2
