# Access Compliance Report

## Public Rights-of-Way

| Intersection ID: 23171 | Main Street: CAMILLA_DR | Cross Street: MORROWICK_RD | Location: NE |
| ADA ID: 232D22BF722E | Ramp Type: PerpDiag | Initial Pass/Fail: Fail | Overall Compliance: No |

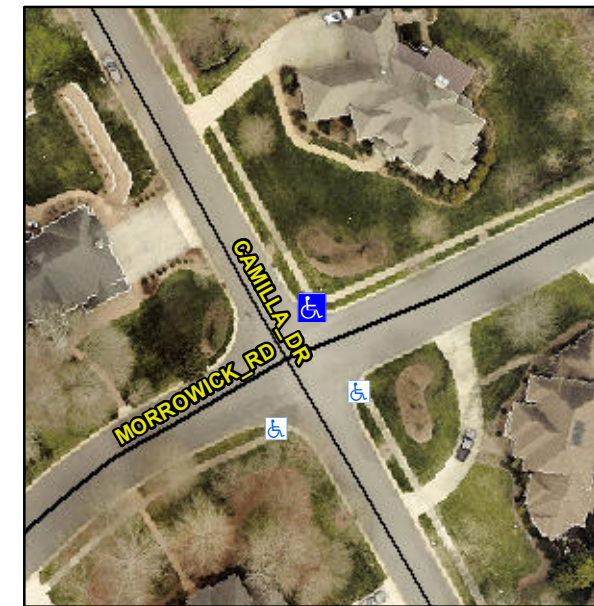
| | | Severity Score: 60 | |

**Not Found, R304.5.1, R304.5.3**

| Compliance | Description | Data | Compliance | Description | Data |
|---|---|---|---|---|---|
| N/A | Ramp Length (in) | 91.0 | Yes | Ramp Slope (%) | 6.9 |
| No | Ramp Width (in) | 24.0 | No | Ramp XSlope (%) | 7.2 |

**Remove & Replace Curb Ramp With Two New Directional Ramps or Equivalent.**
